This update will bring you up another month to 4/3/17.

**Headliner Sail Area:**

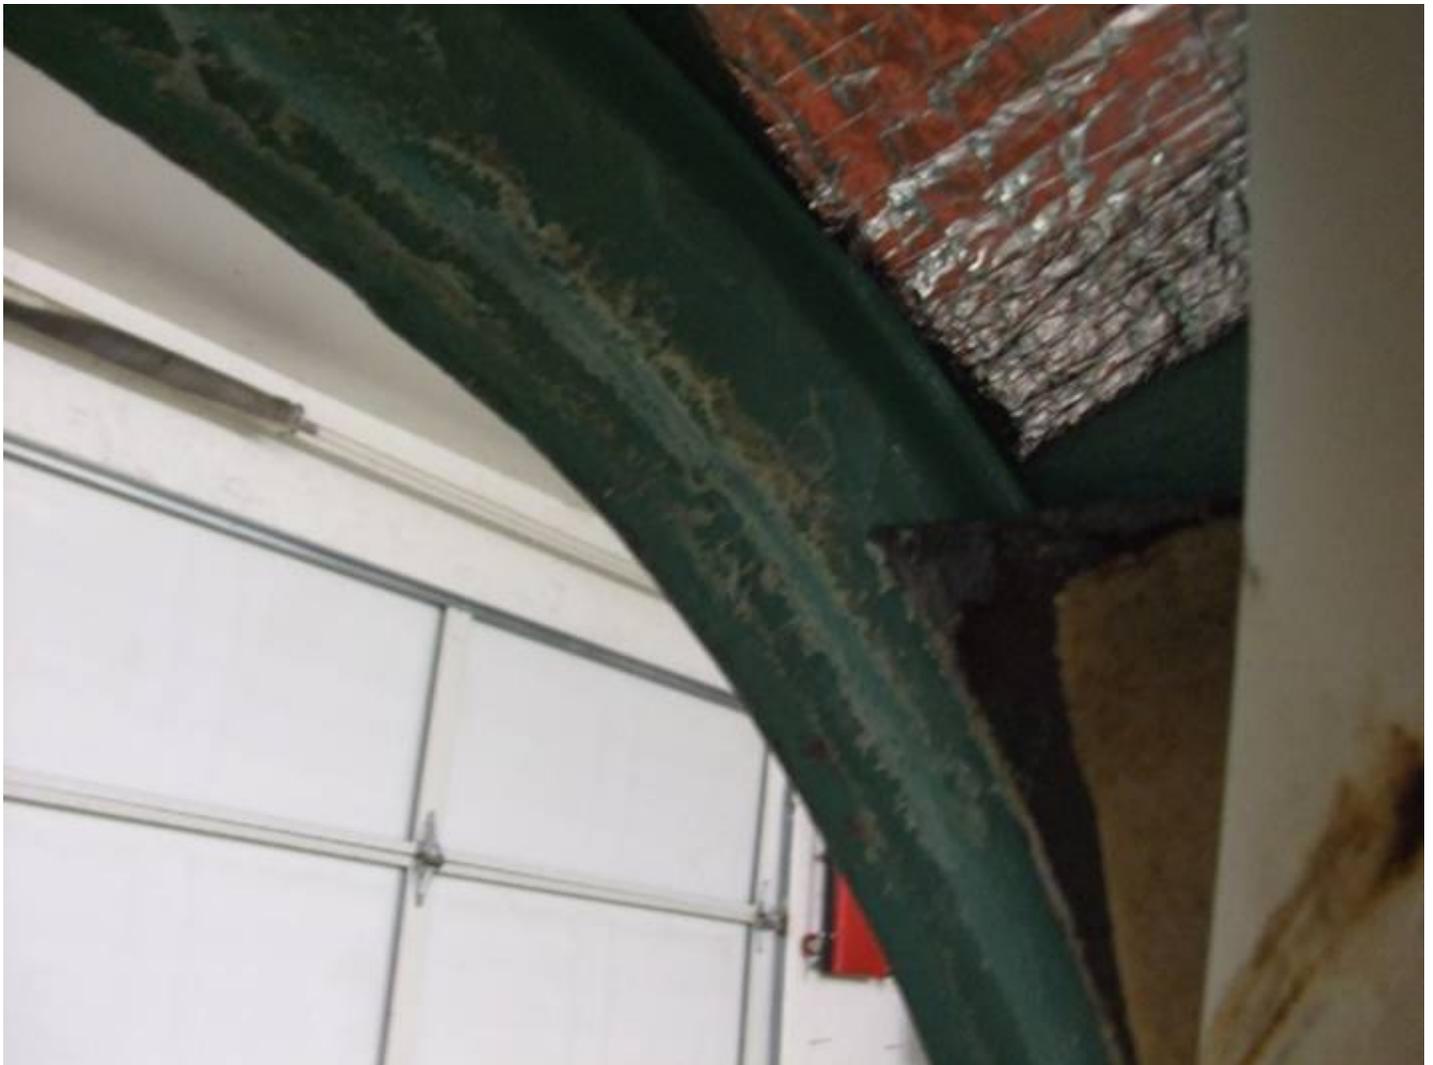
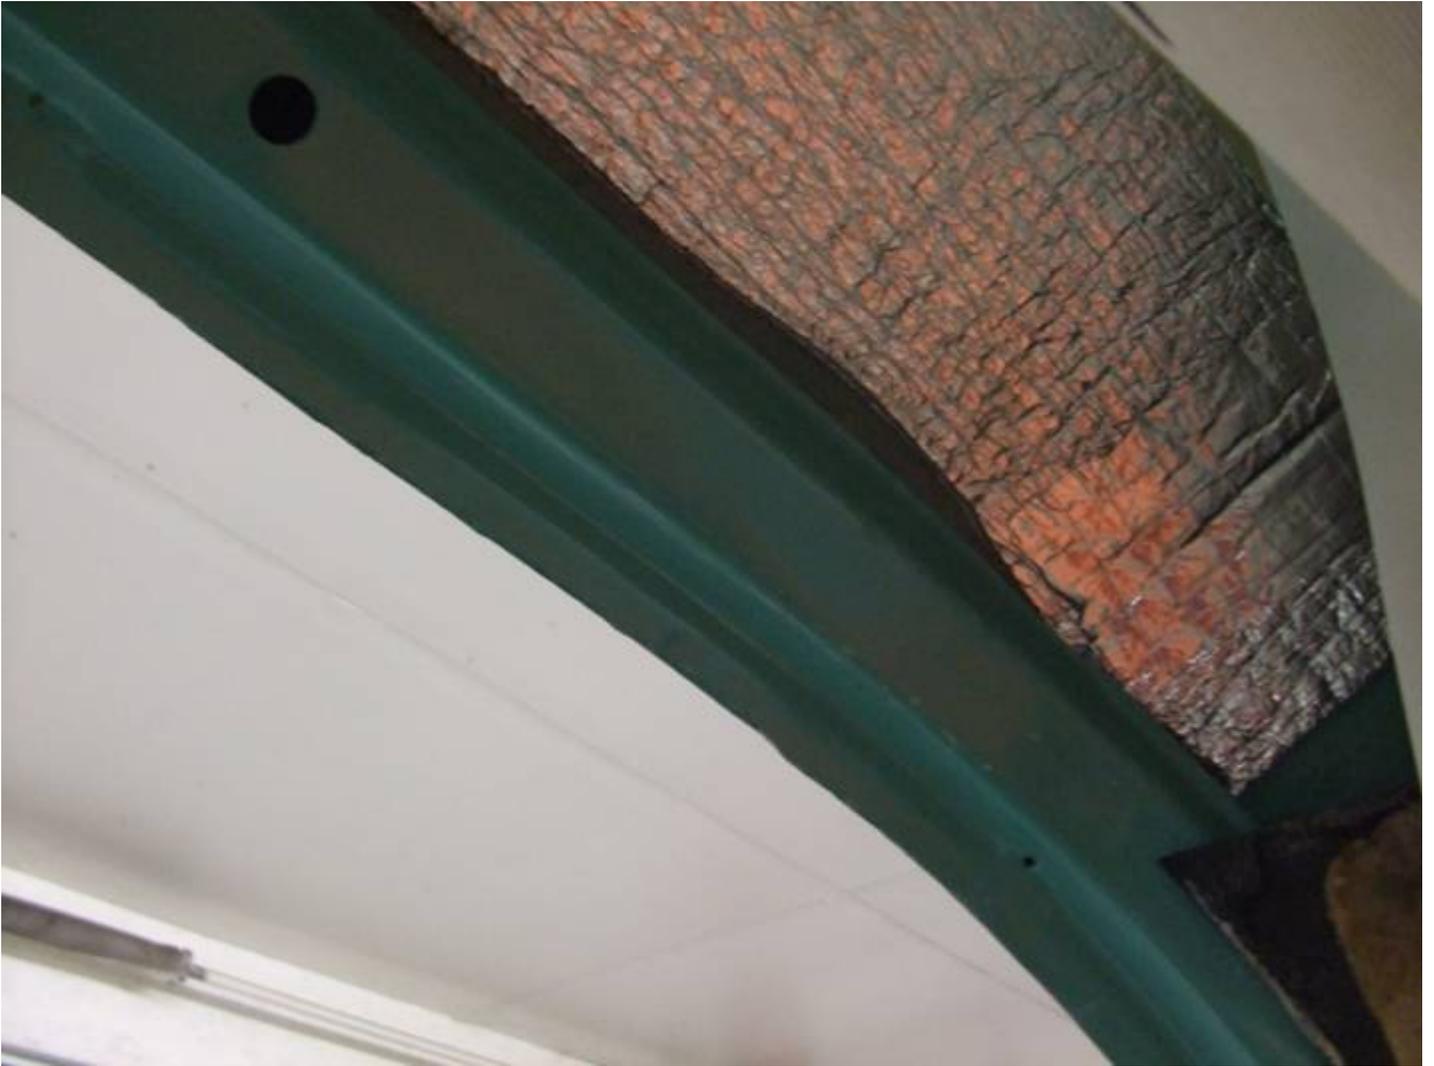
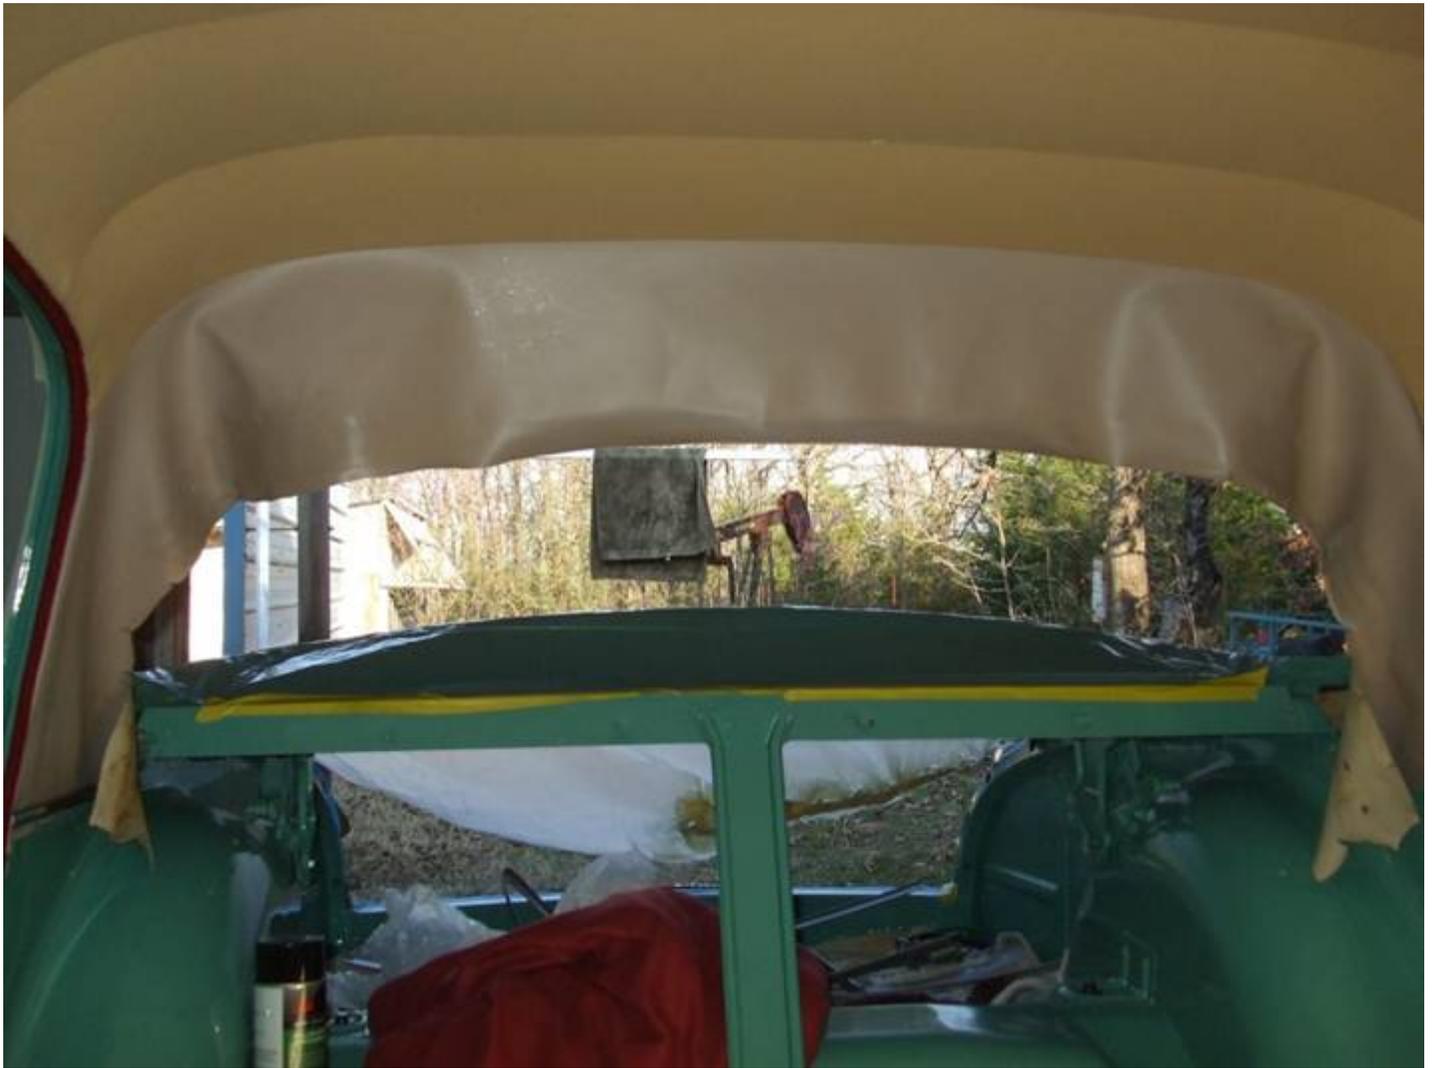
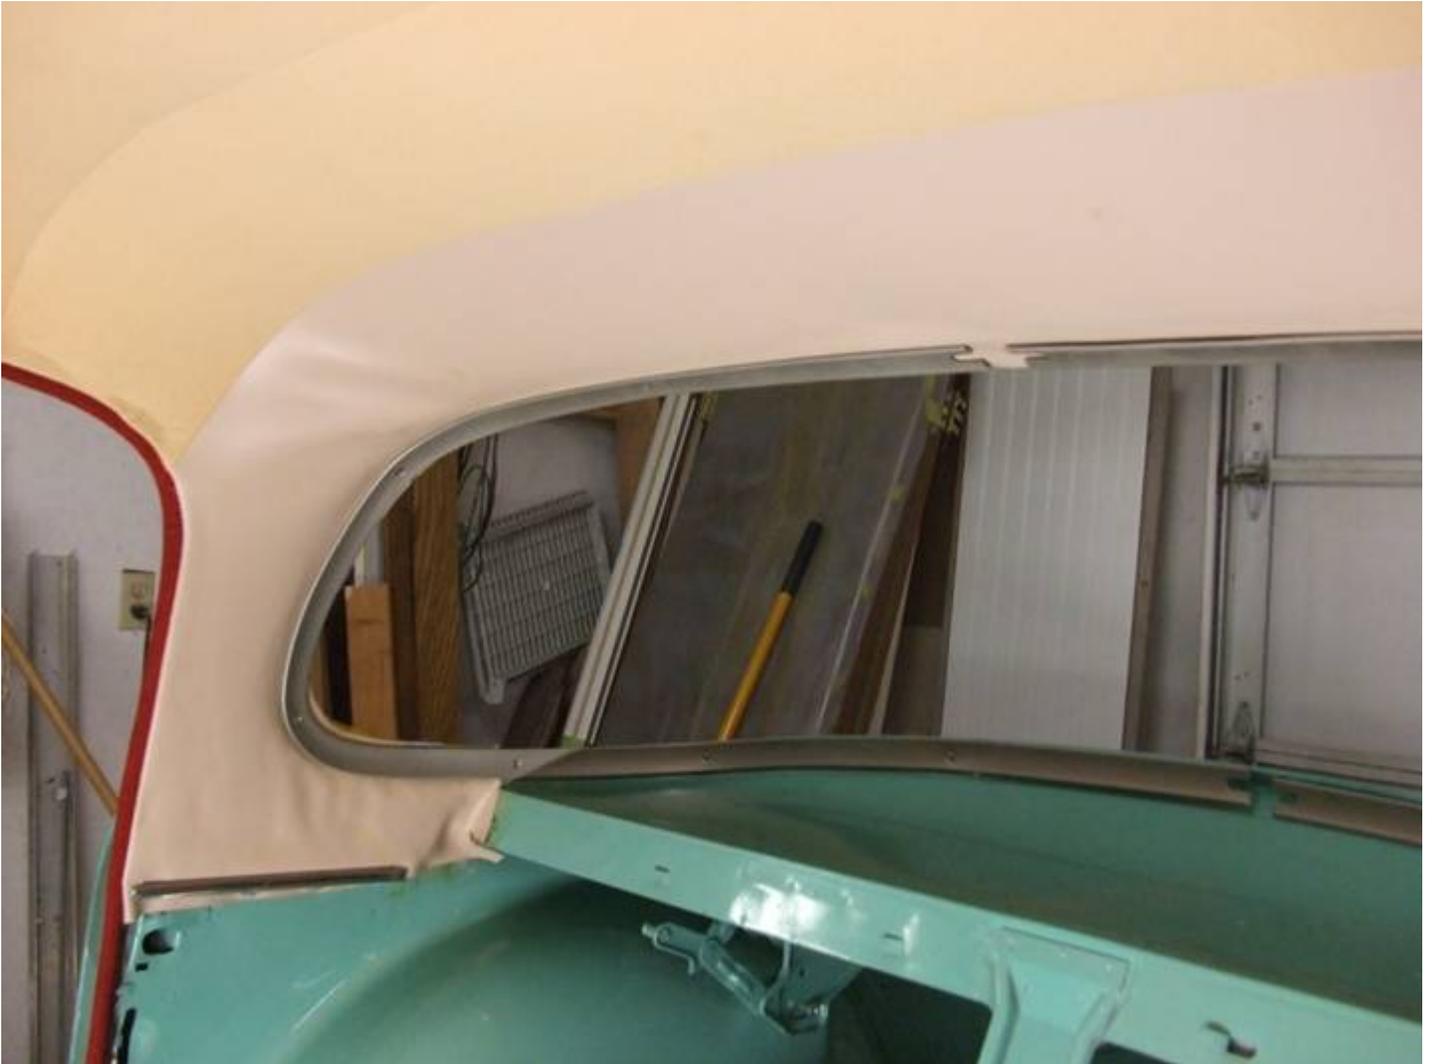
I had not initially used the 3M 8090 super contact cement and paid the price later because in the sail area it almost all let go and I had sail material hanging all over. The contact cement used was removed with wax and grease remover and elbow grease.

The sail area was installed to the best of **my** ability. I still ended up with a couple a wrinkles. Prematurely cutting off some of the front of the sail panel will forever plague me. To help hold the sail area in place until the window installer could get out to our place, the inside garnish mouldings were screwed in to place.

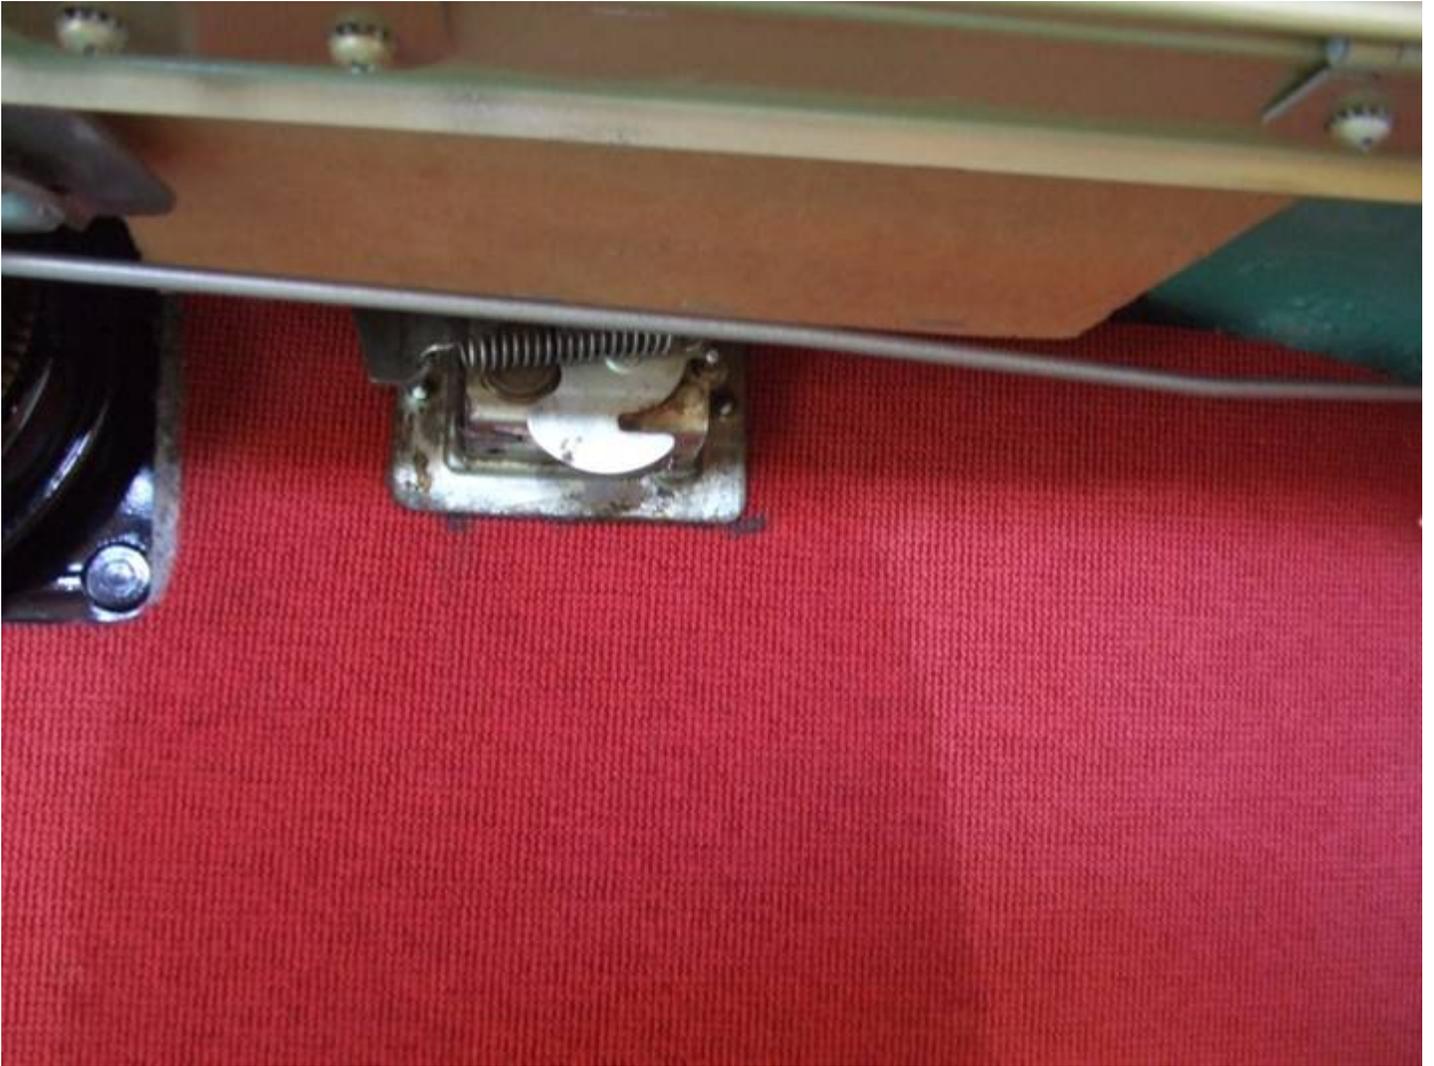
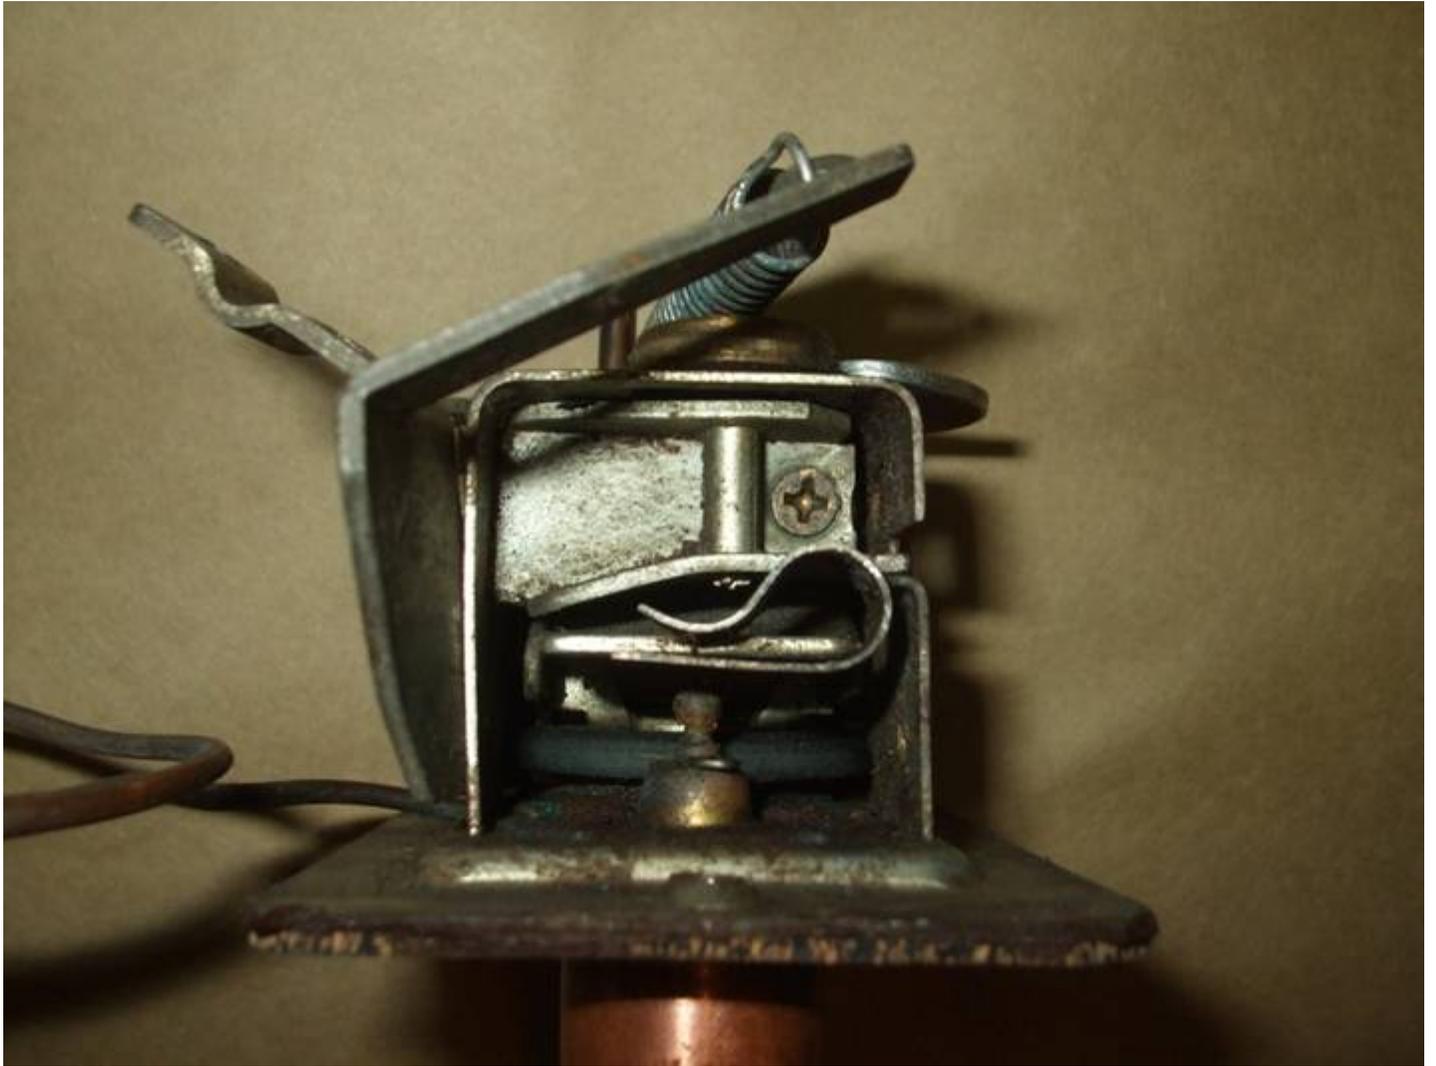
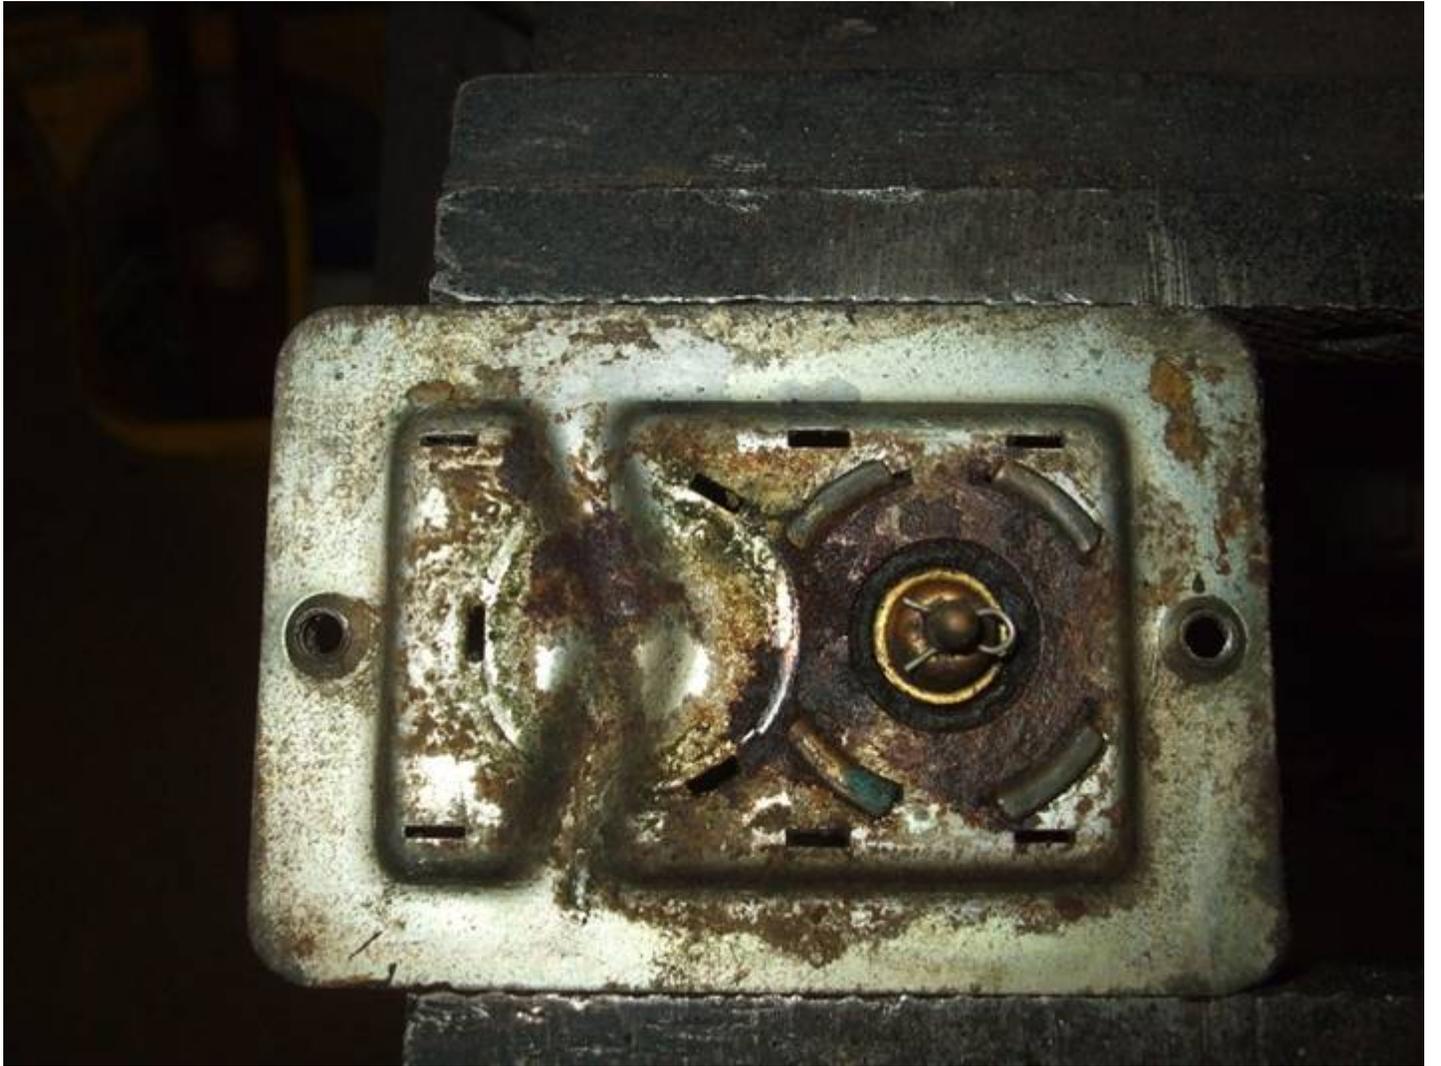
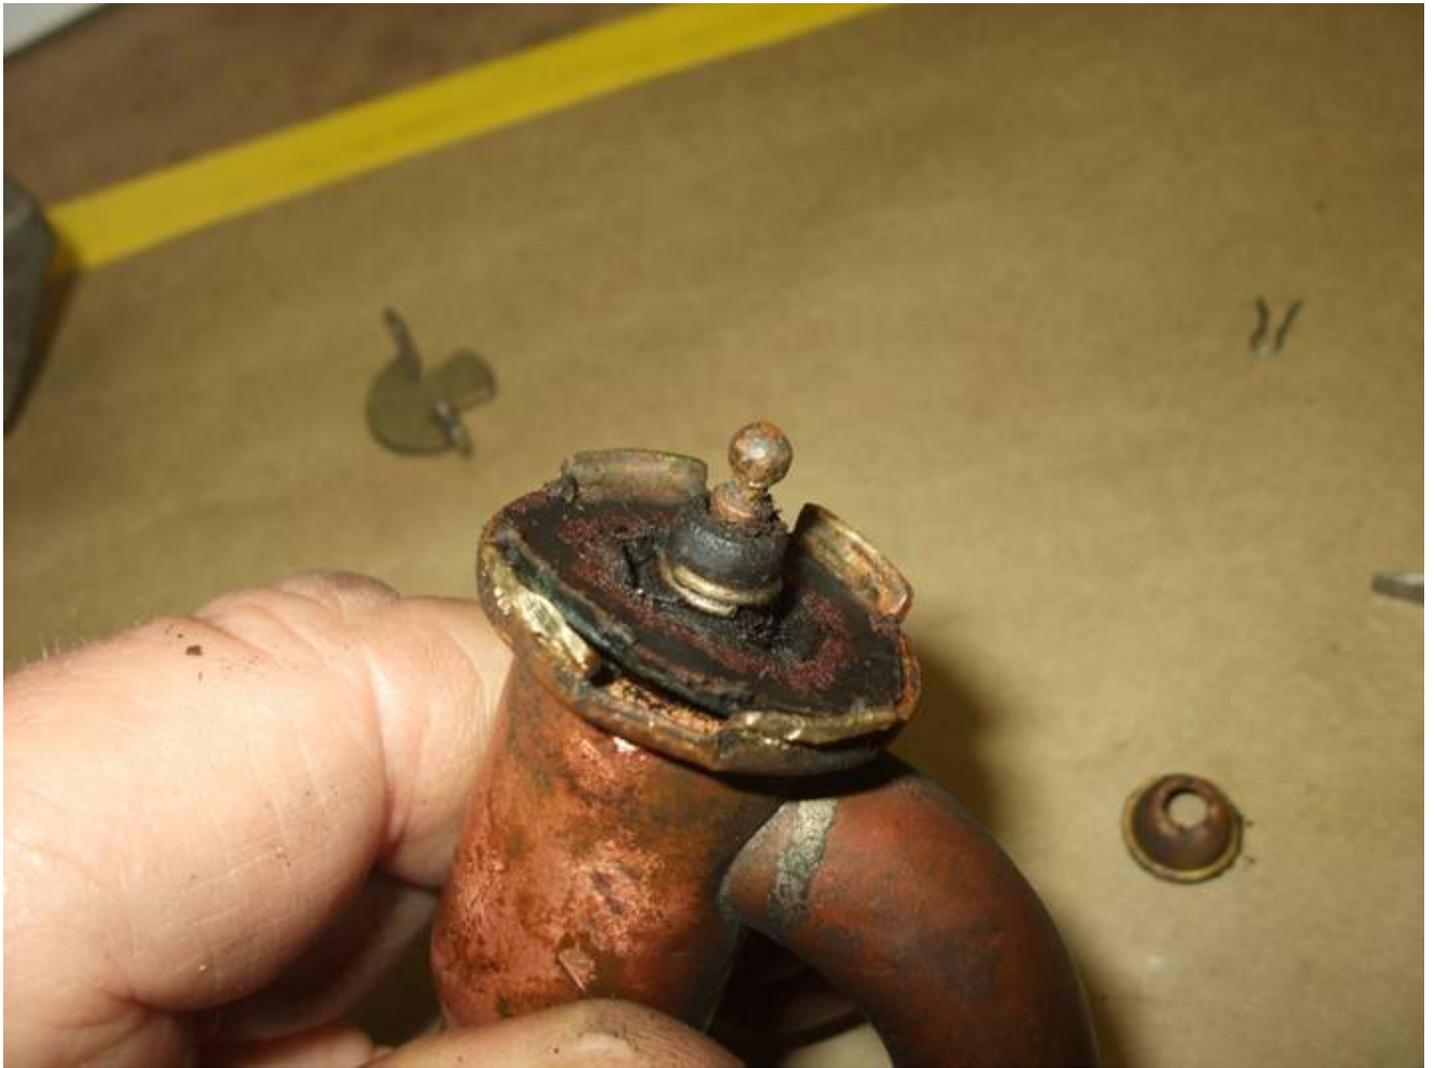
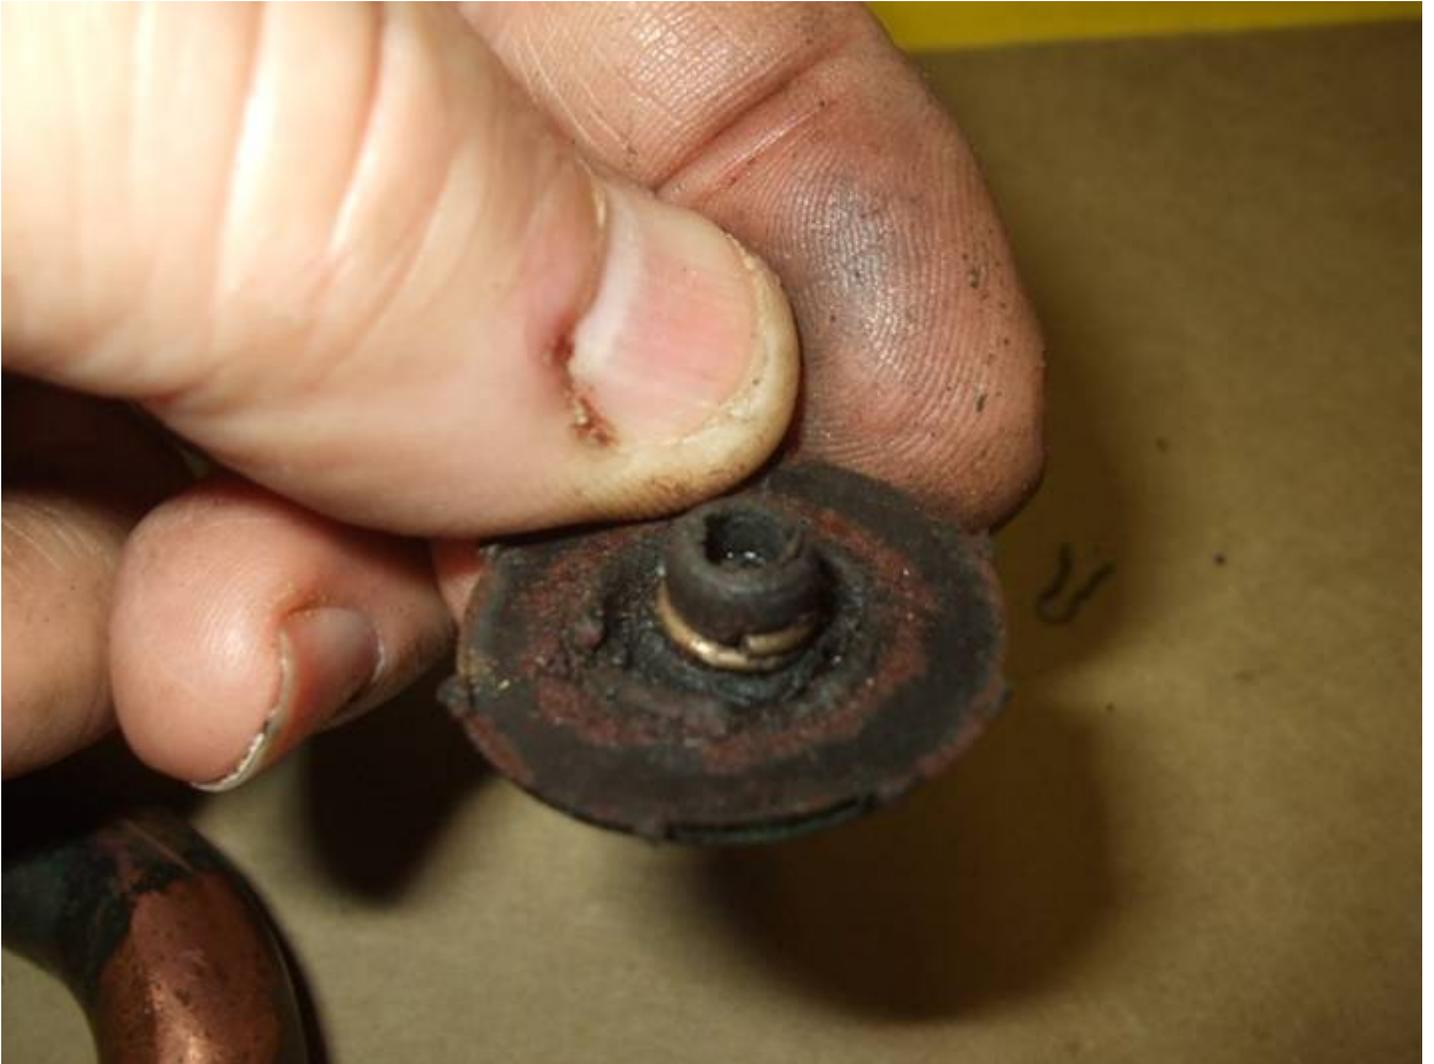
**Water Control Valve:**

The water control valve leaked on the new dash pad.

This was the seal that was leaking. Fortunately I was able to purchase a repair kit for the control valve which is basically the seal itself. It stopped the leaking.

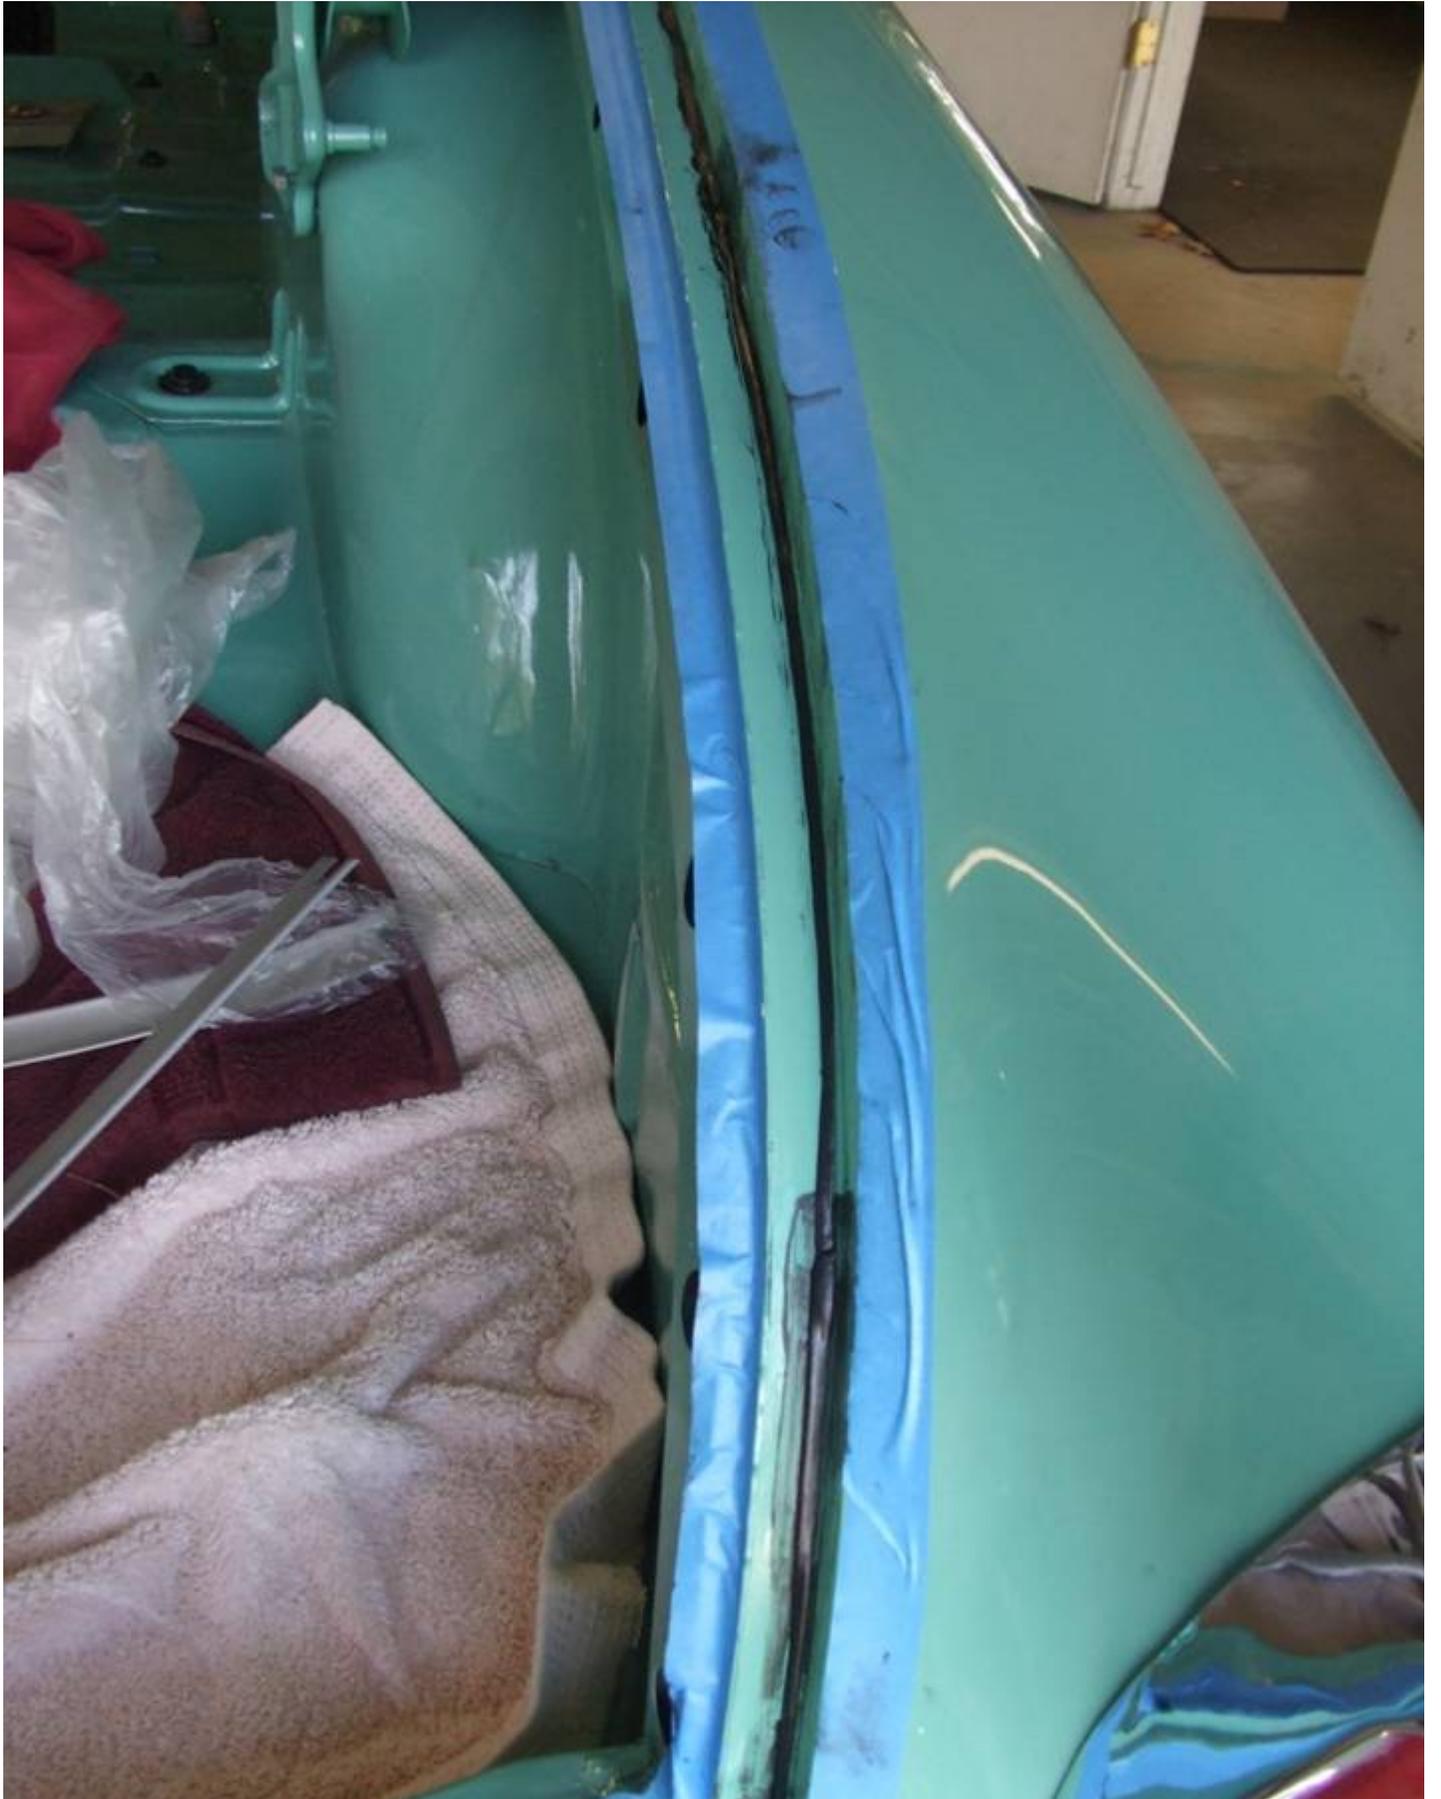
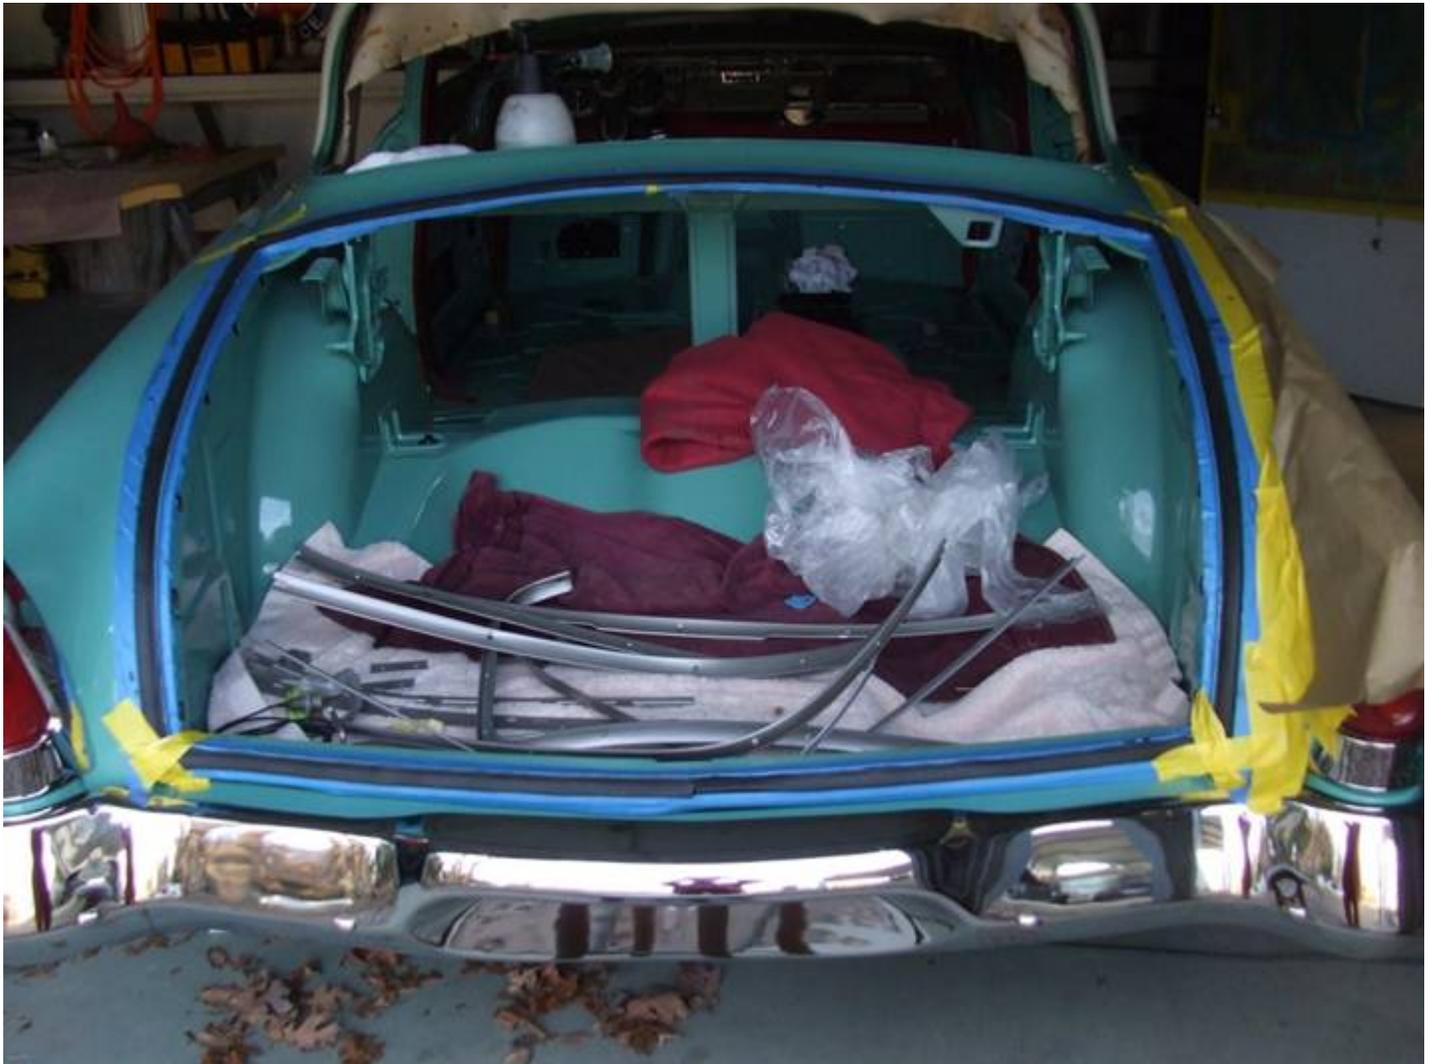
**Trunk weather-strip:**

The shop manual calls for a sealant between the rear fenders and the shell. I used the 3M strip-caulking.

I tried to keep the cement off the paint by using the blue masking tape. The edges were taped down until they could dry well.

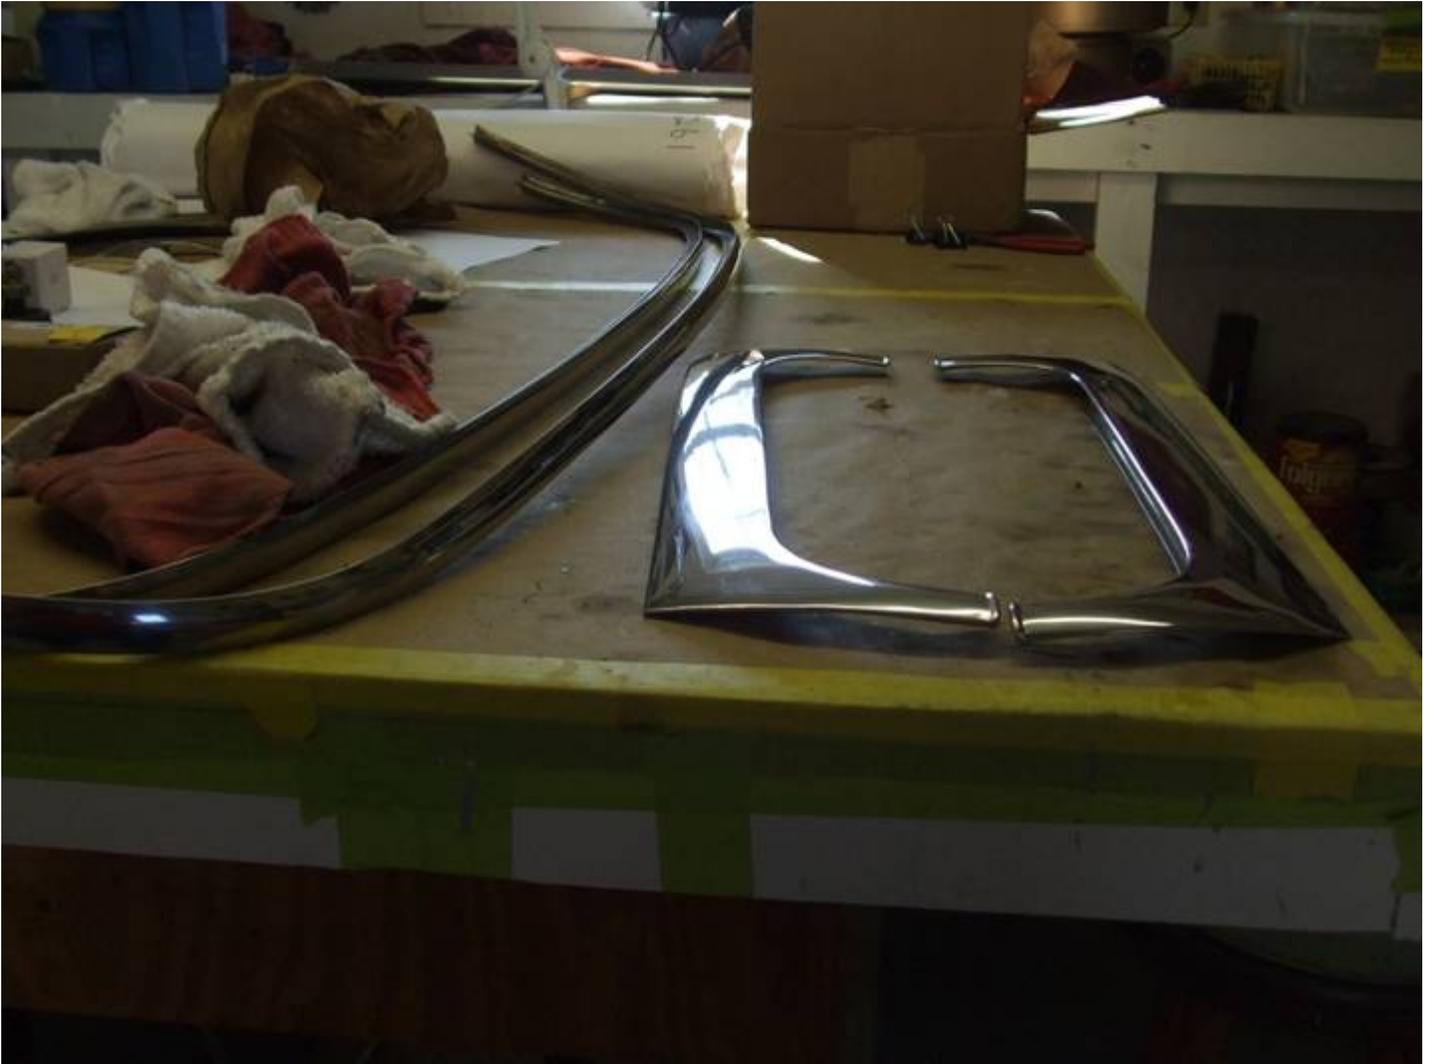
**Front and rear glass installed:**

Most, if not all of you, know that the stainless trim around the windshield and rear glass has to be placed in the rubber gaskets before they are installed on the car. I used the buffing wheels and compounds to polish the stainless. I was a little disappointed in the luster of the stainless. I had a thought (little light bulb or God?). I used the 3M #2 polish that I am using to color sand the paint on the buffing pad in my cordless drill. Wow!! It really made the stainless POP.

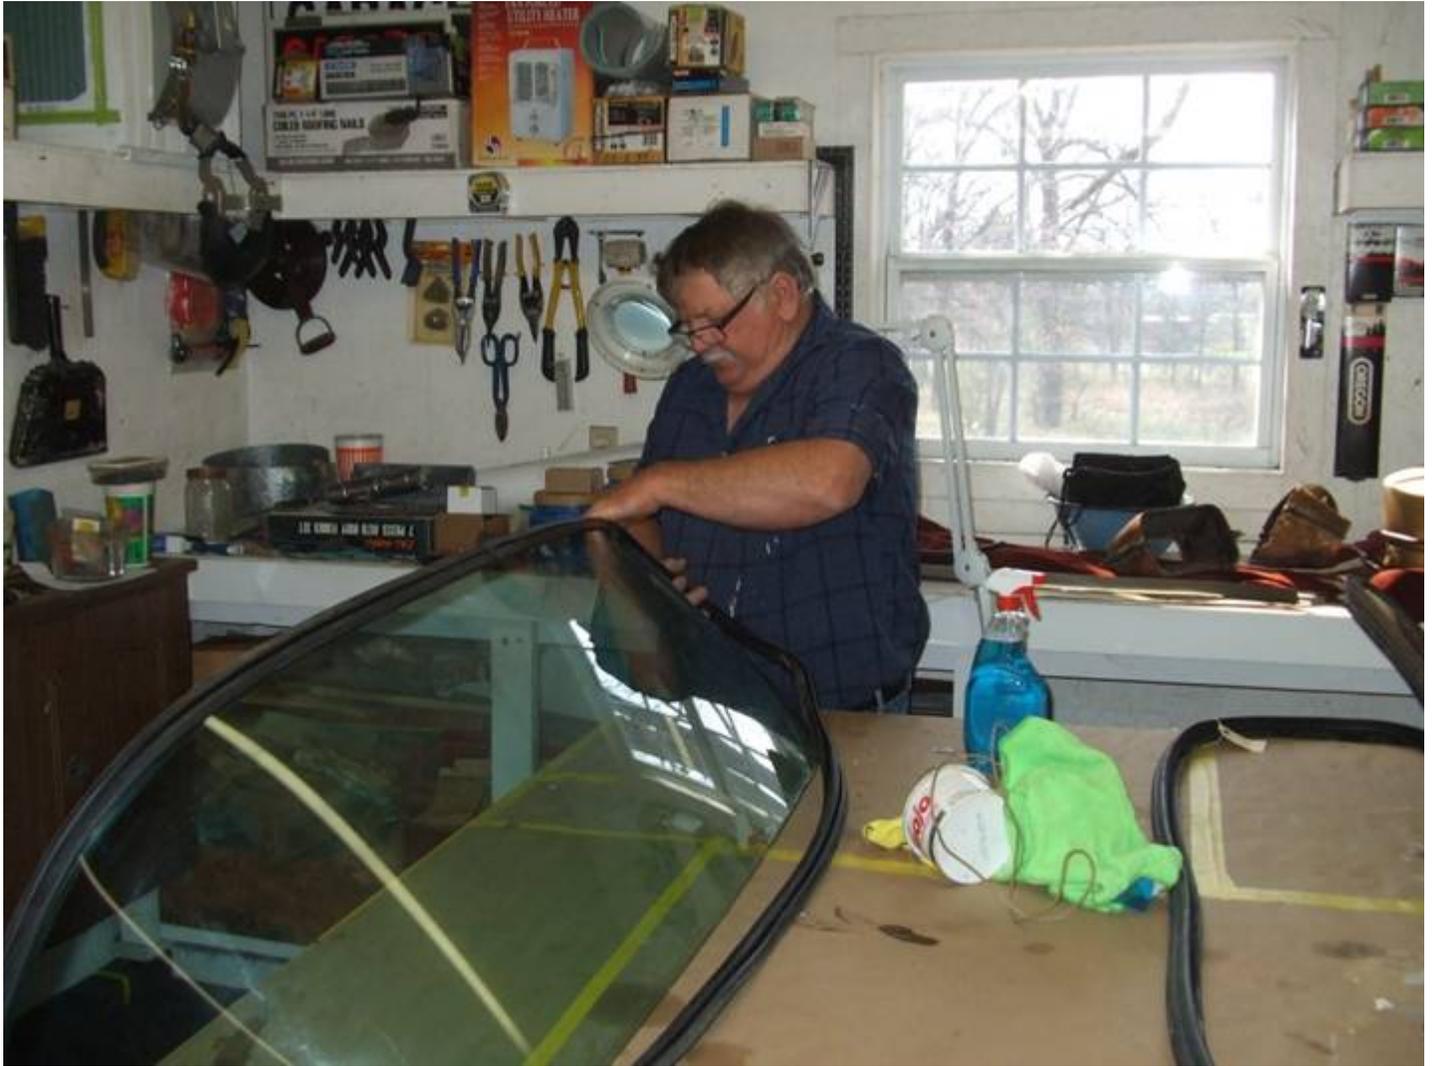
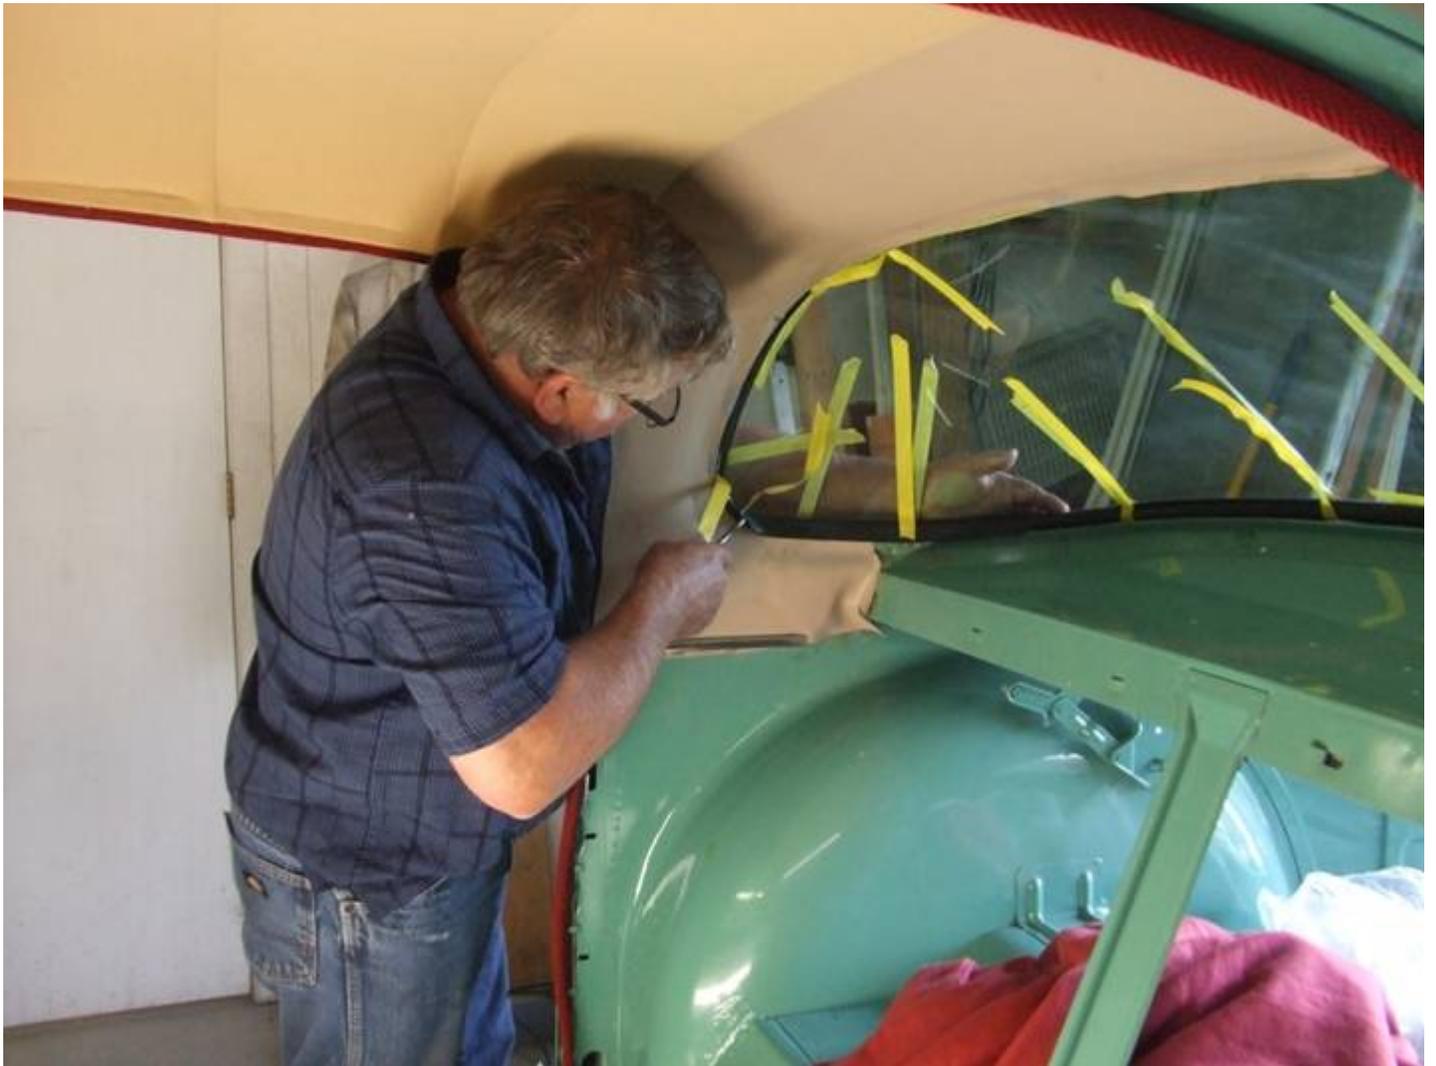
The installer started out with the rear glass. He had brought a piece of rope but did not use it. He had a tool that looked like a curly cue pick. As he slid it along the flange the rubber was pulled up and over the flange. It took him about five minutes to install the rear glass.
