This update will bring you up another month to 4/3/17.

**Headliner Sail Area:**

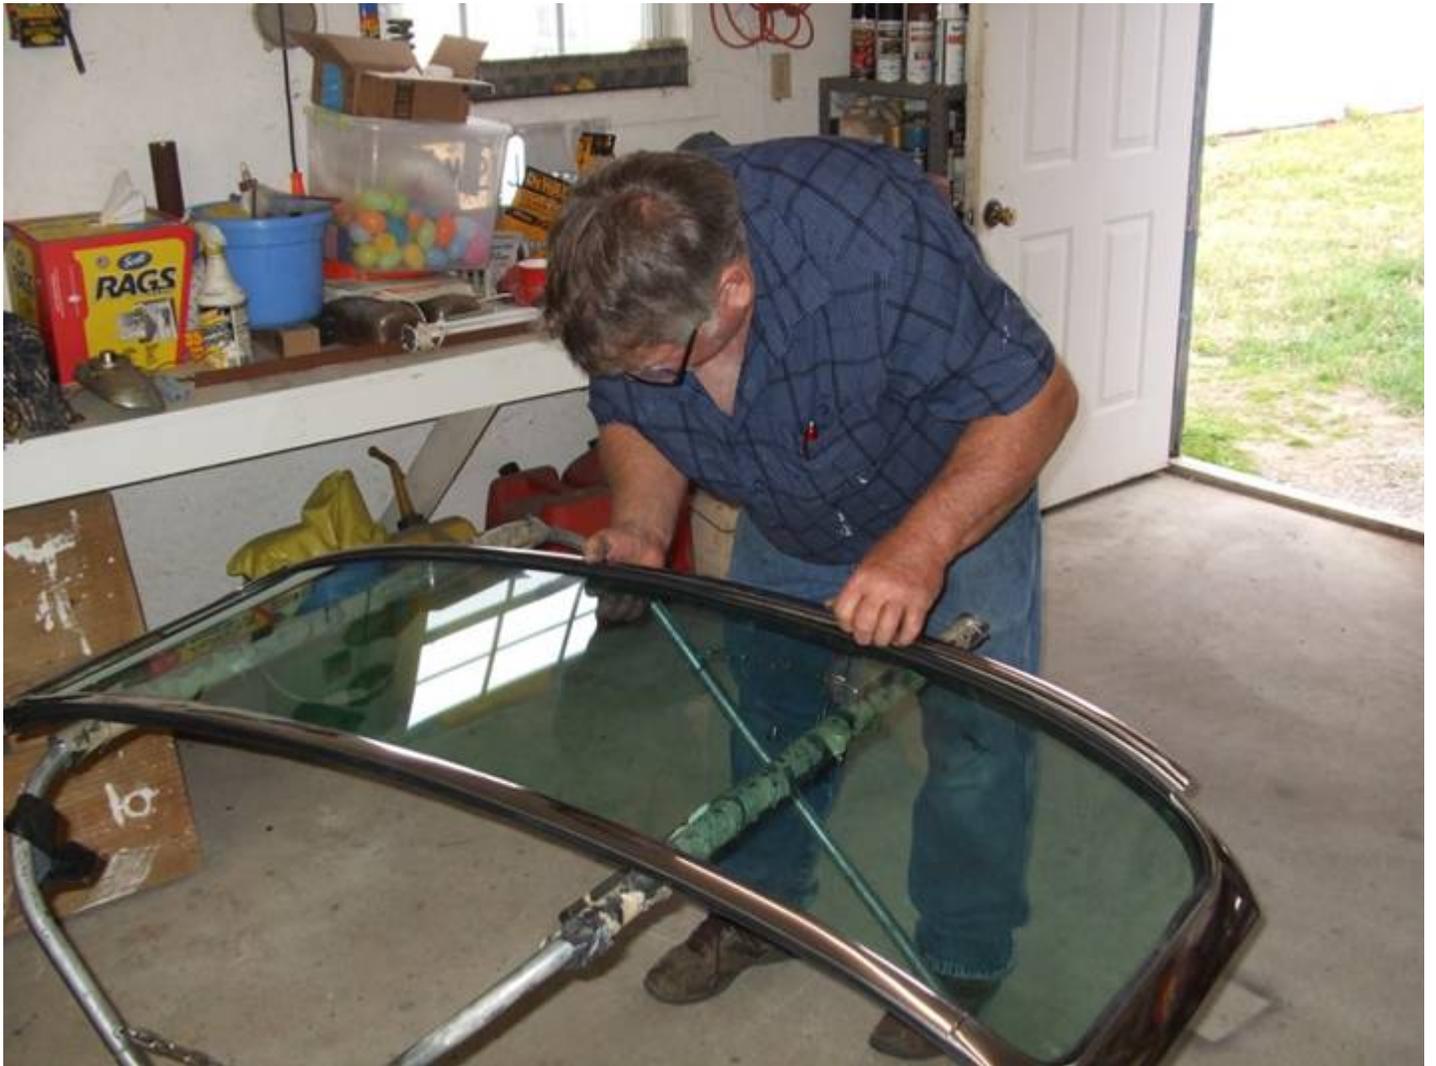
He had to work pretty hard to get the trim around the front glass. He did not use any sealant so it will be interesting if it will leak later. I figure if it does I'll ask him to reinstall it with some goop.

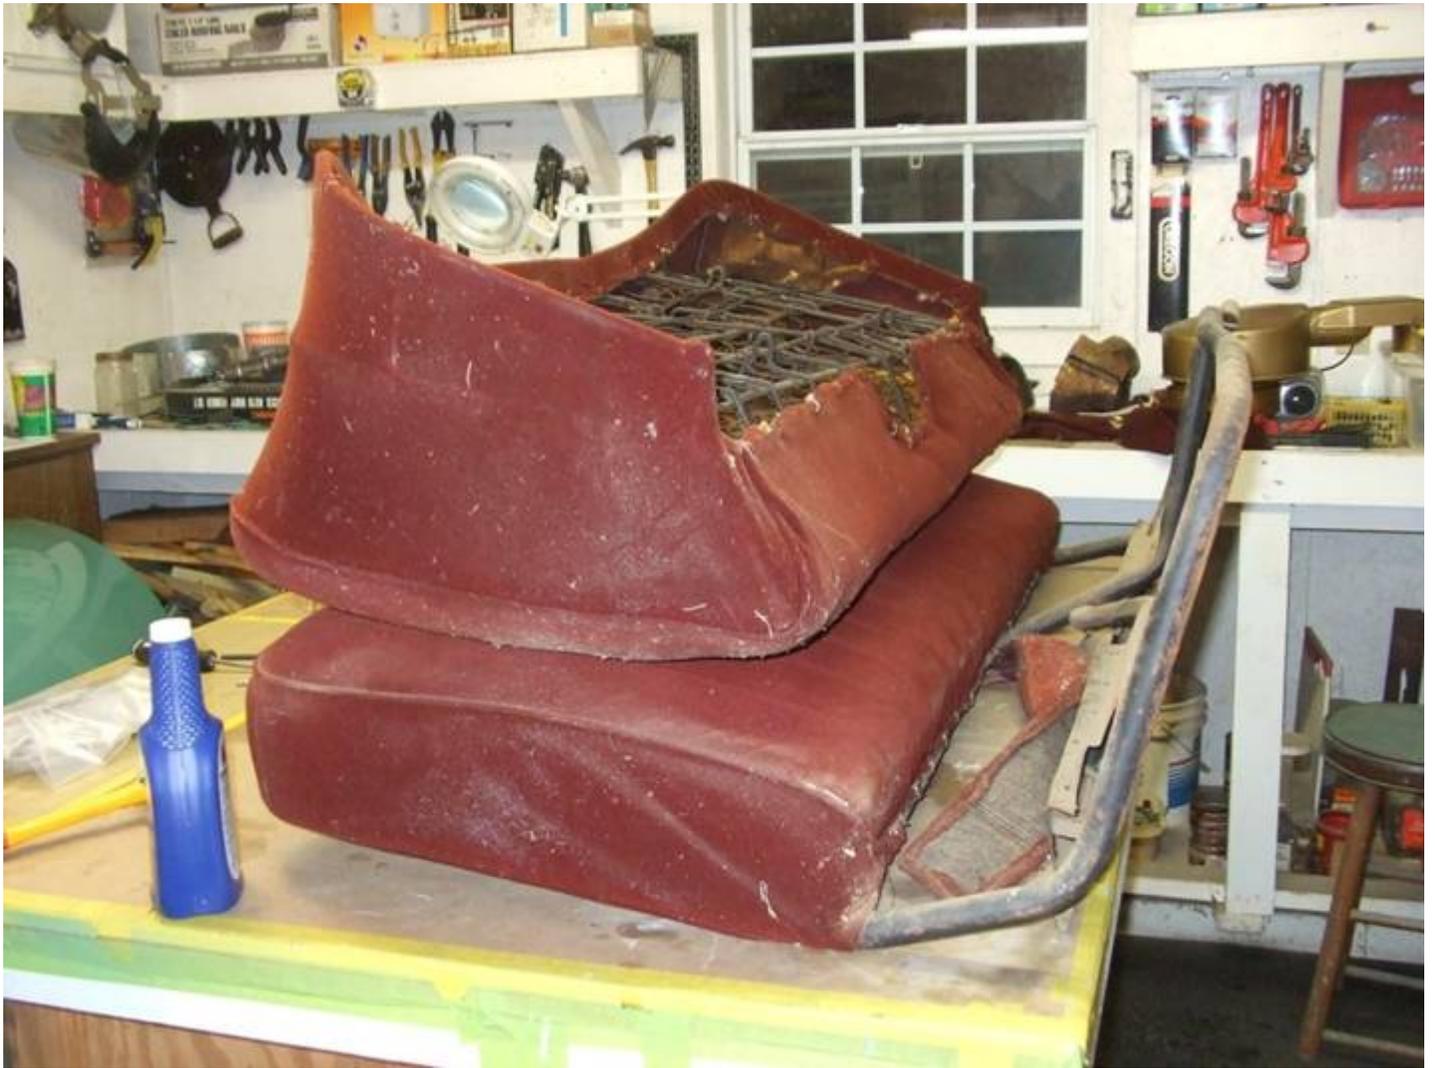
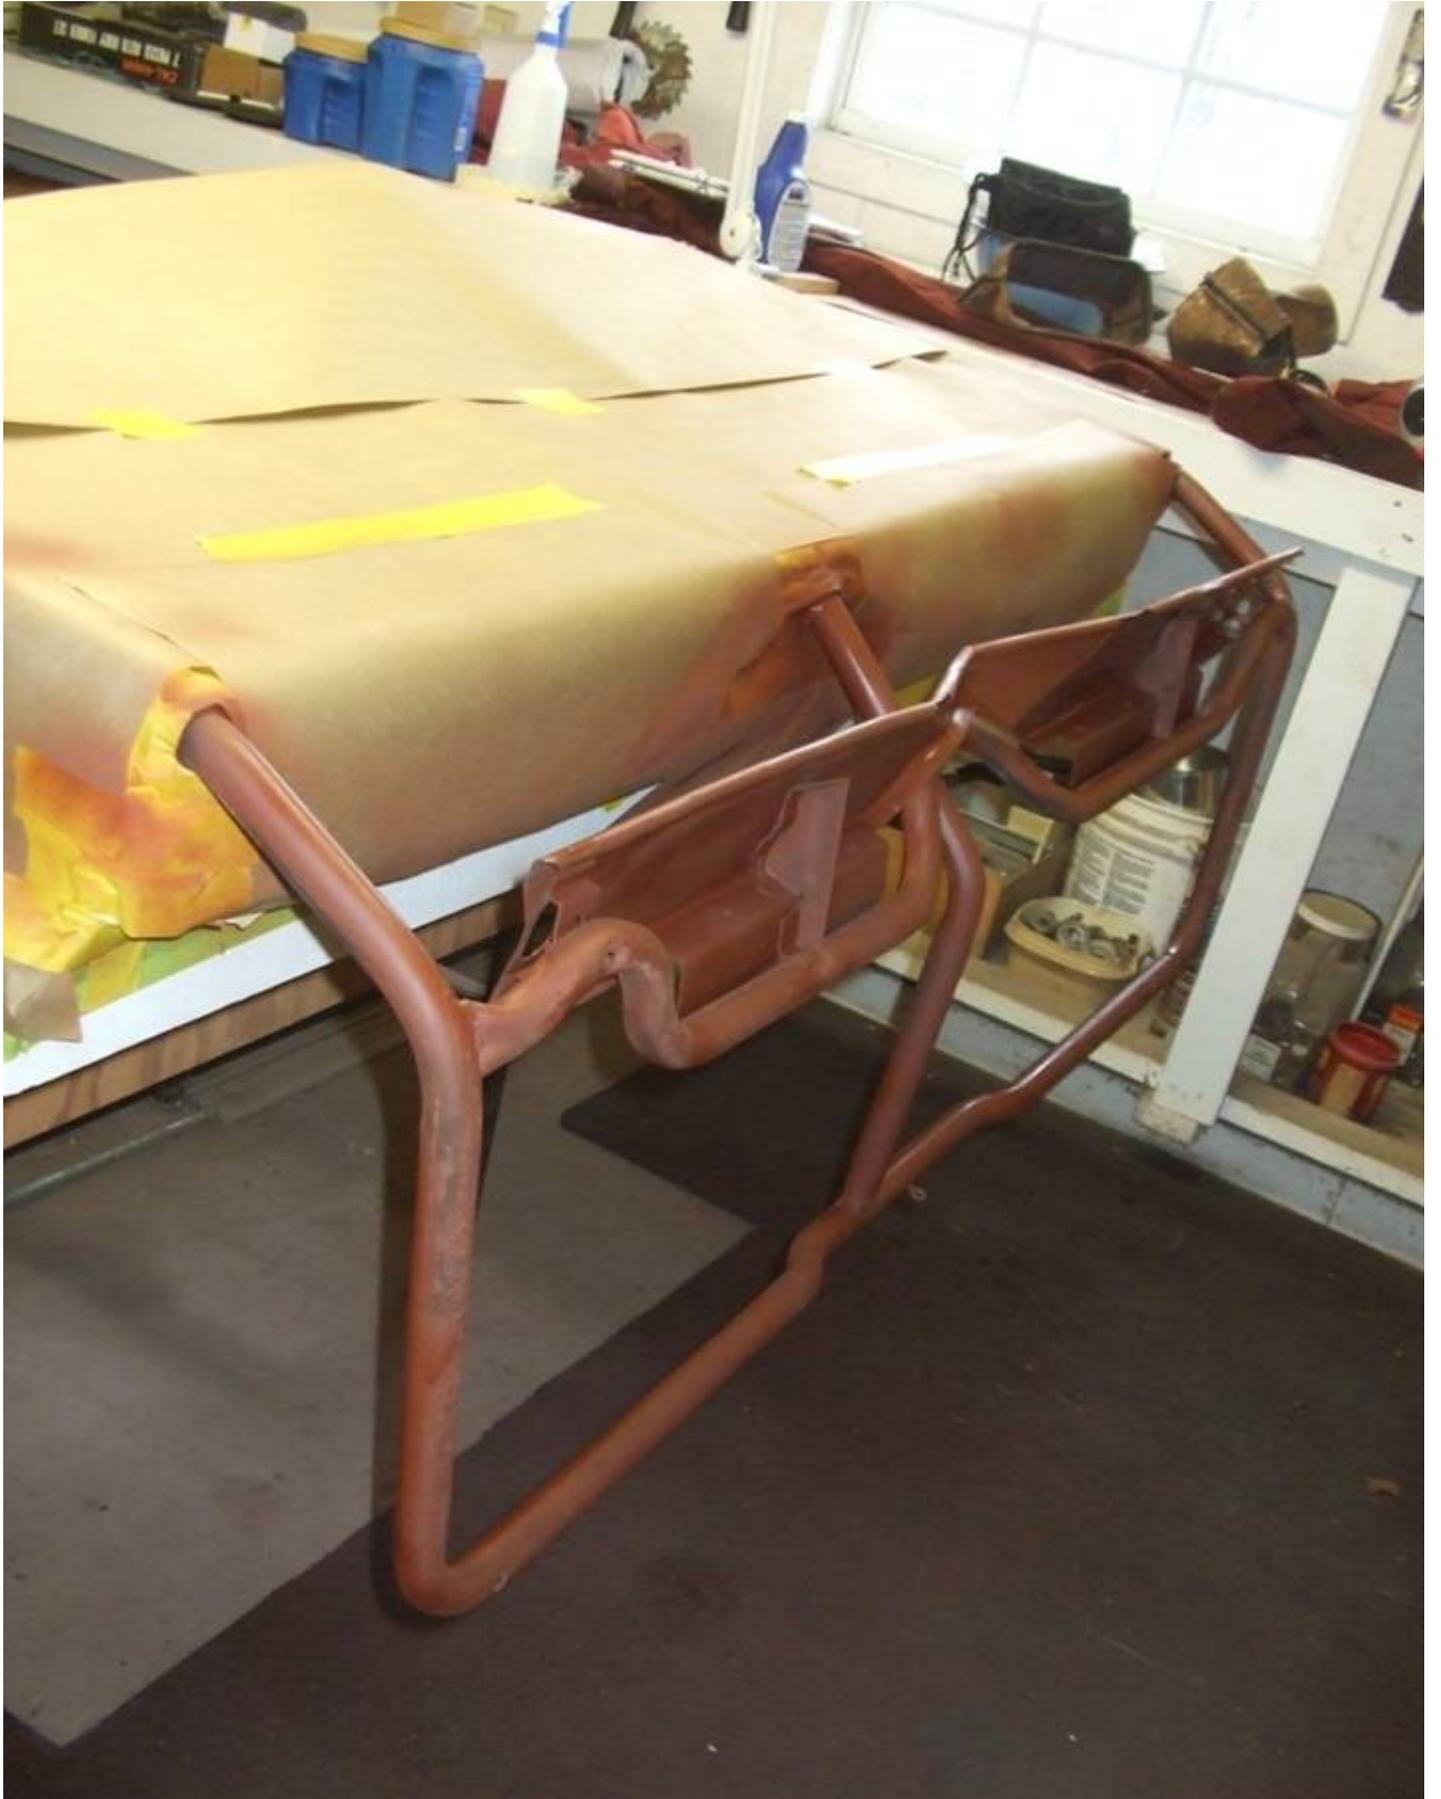
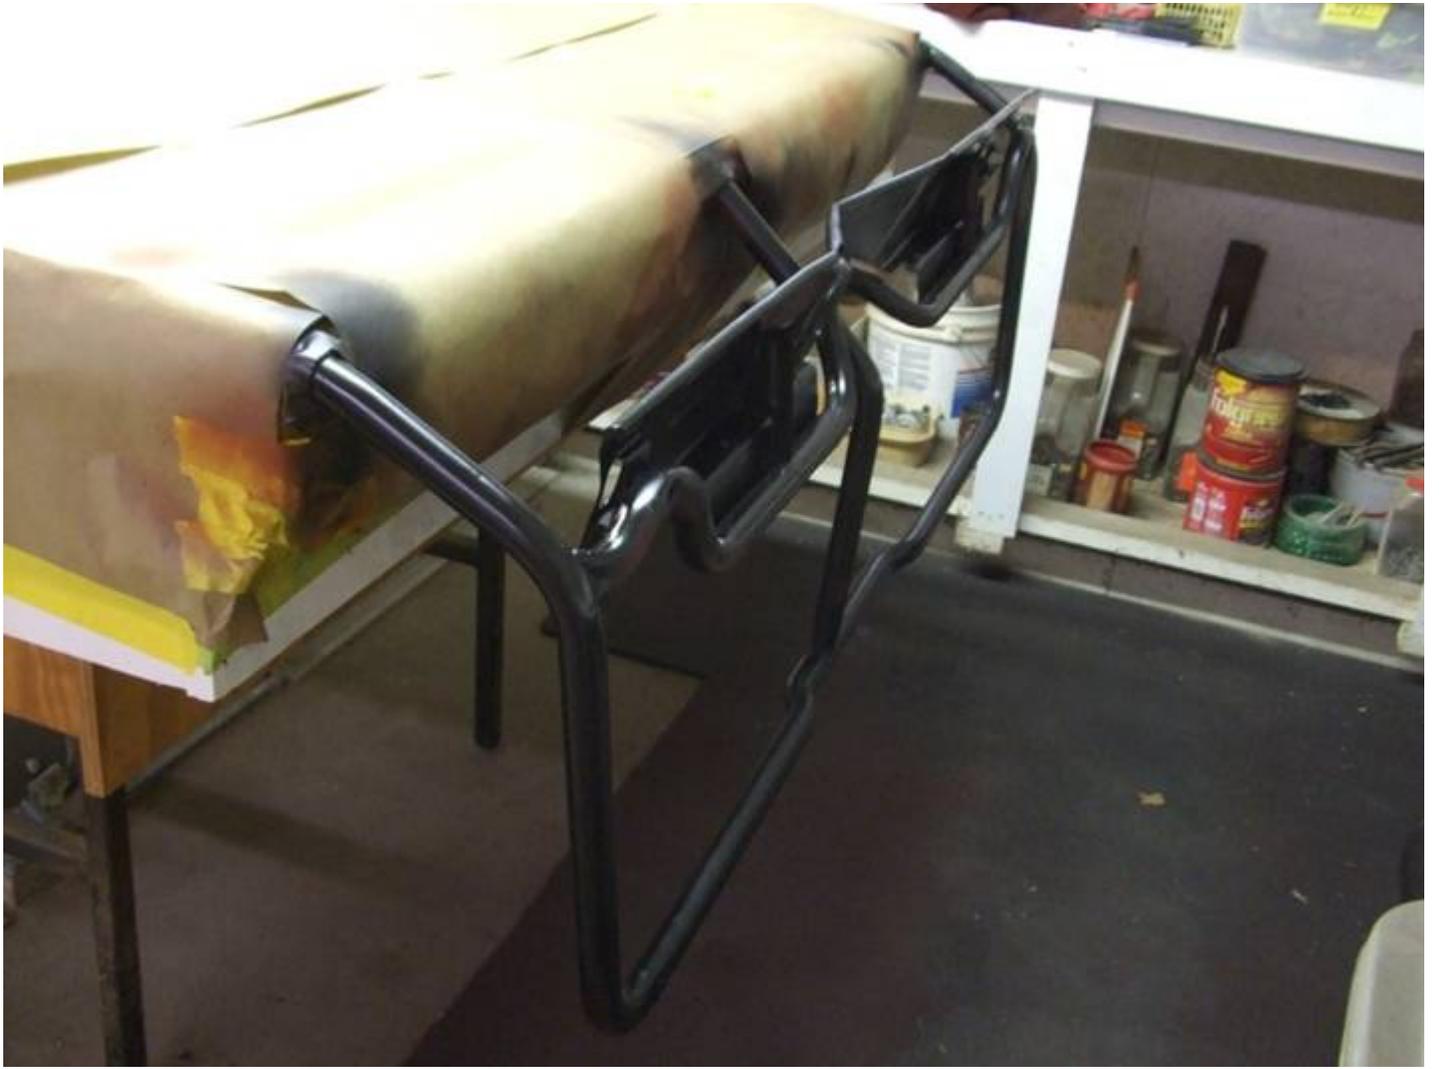
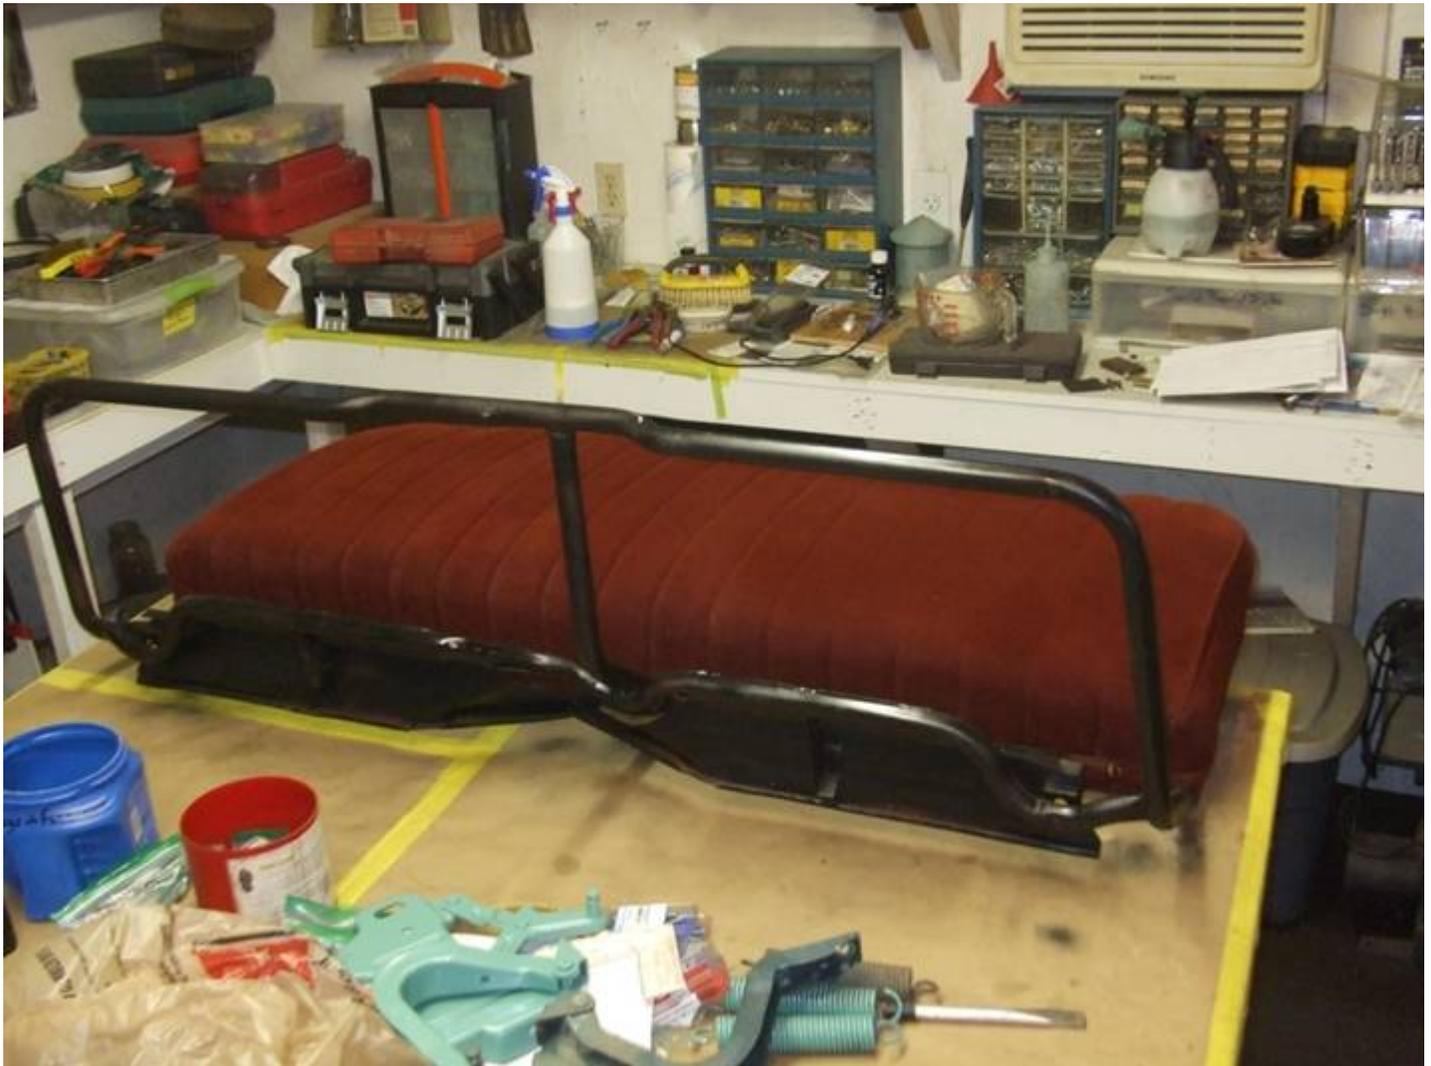
**Front Seat:**

The front seat cleaned up pretty well. It was vacuumed and cleaned with Kirby carpet cleaner. The metal frame was painted with Rustoleum rusty metal primer and black rattle can paint.

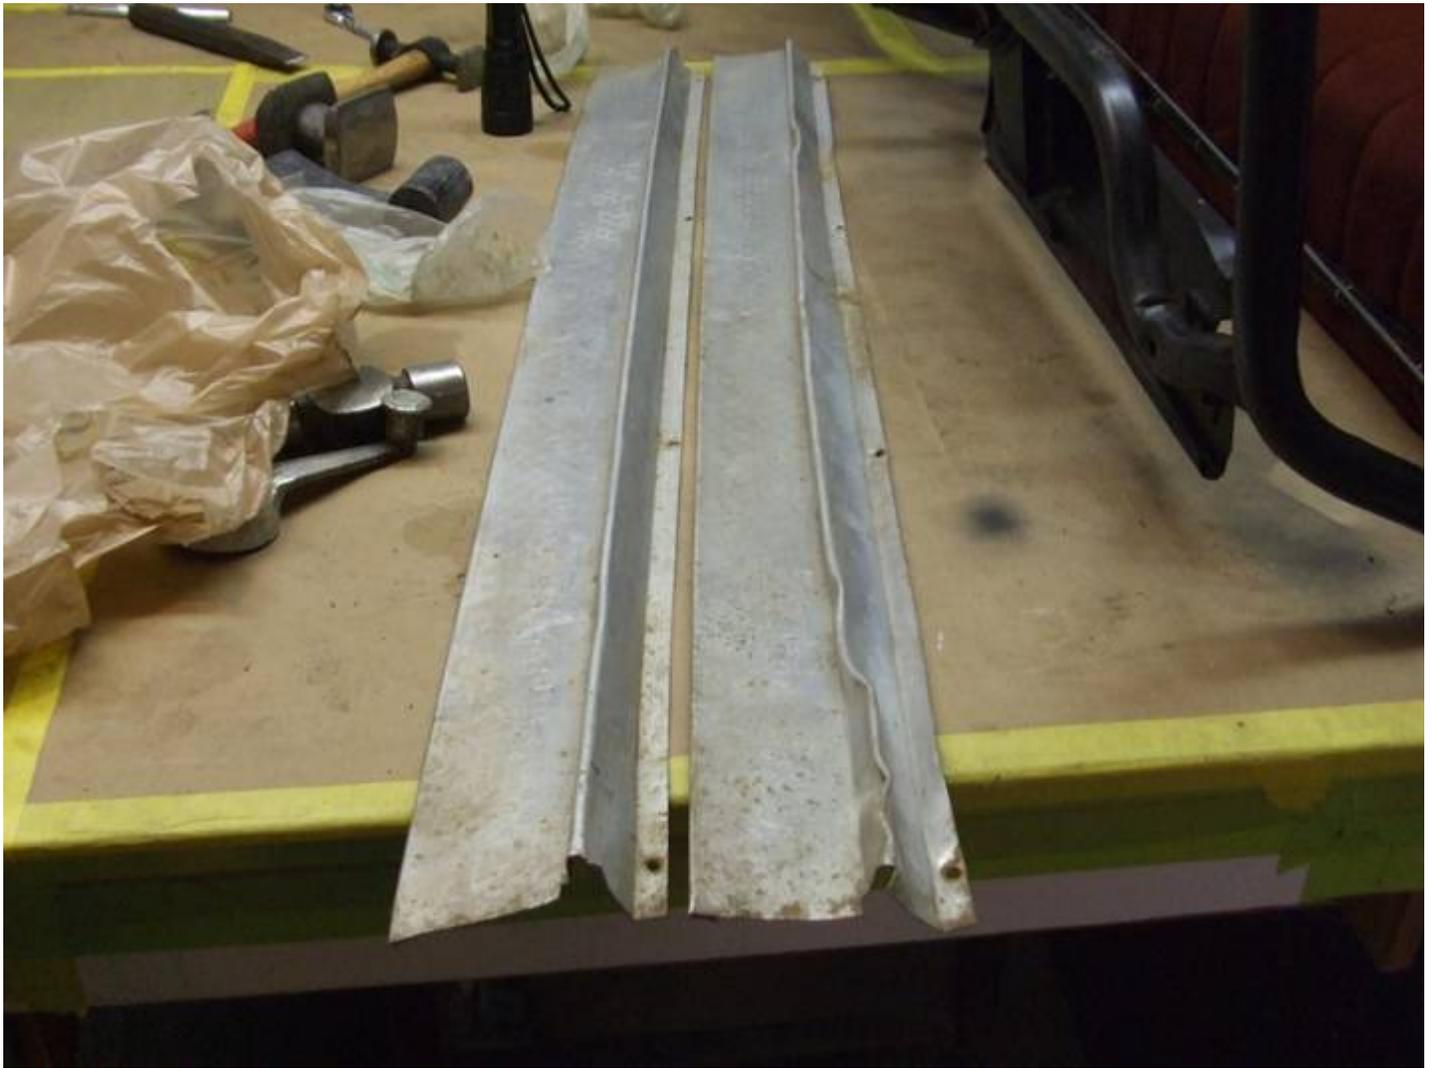
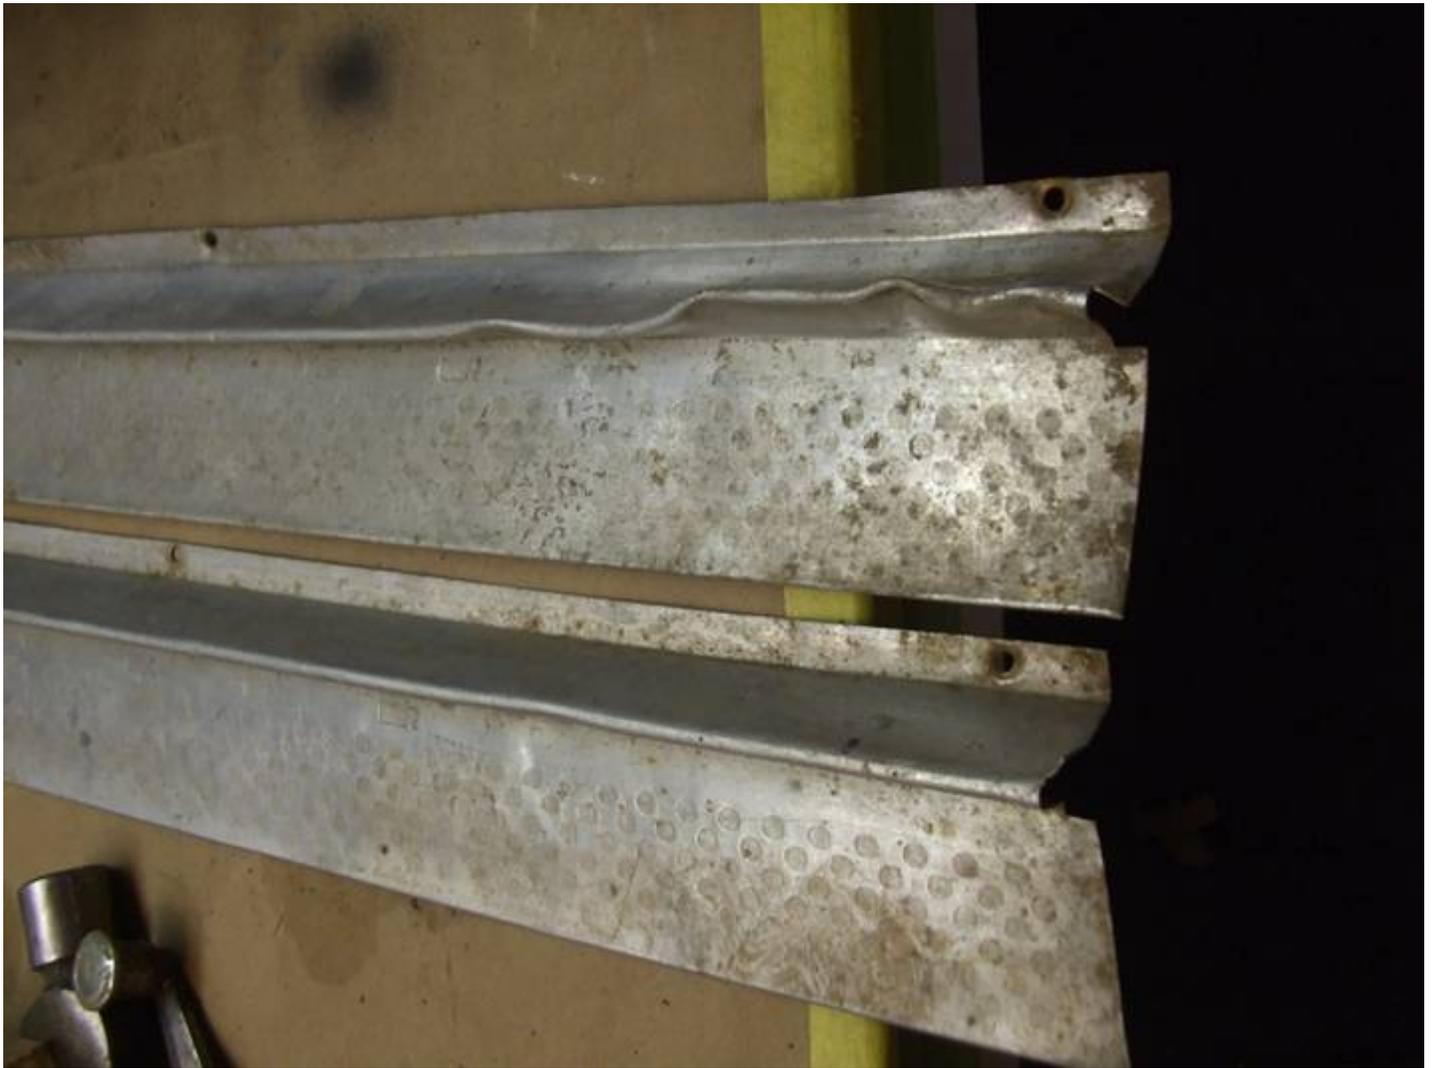
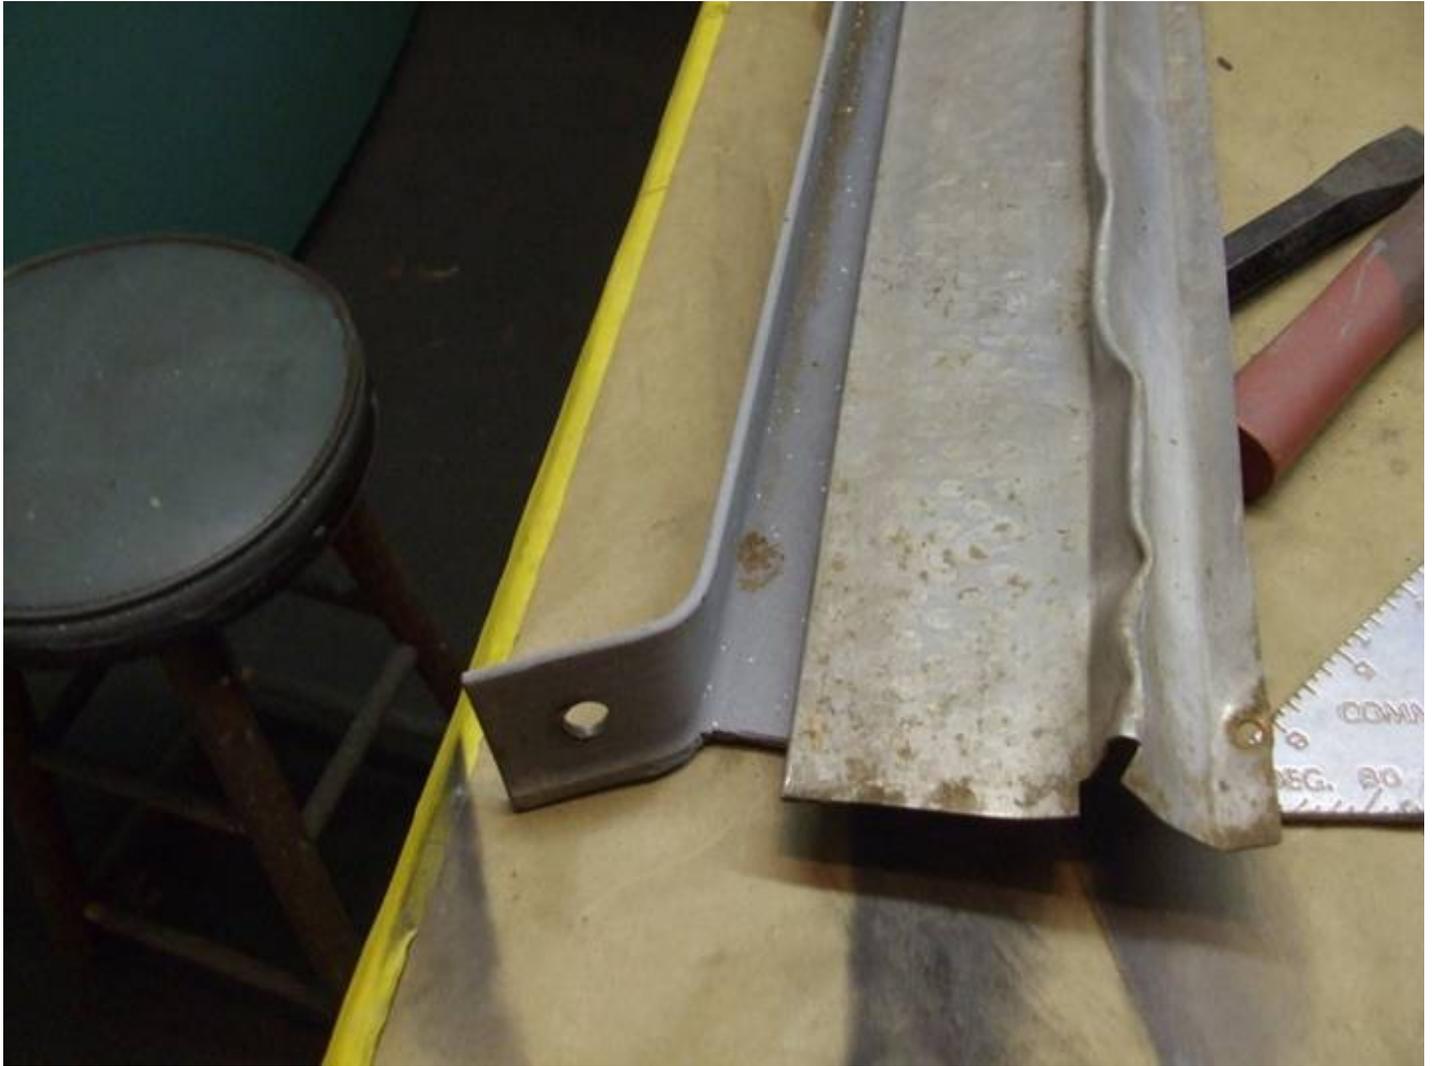
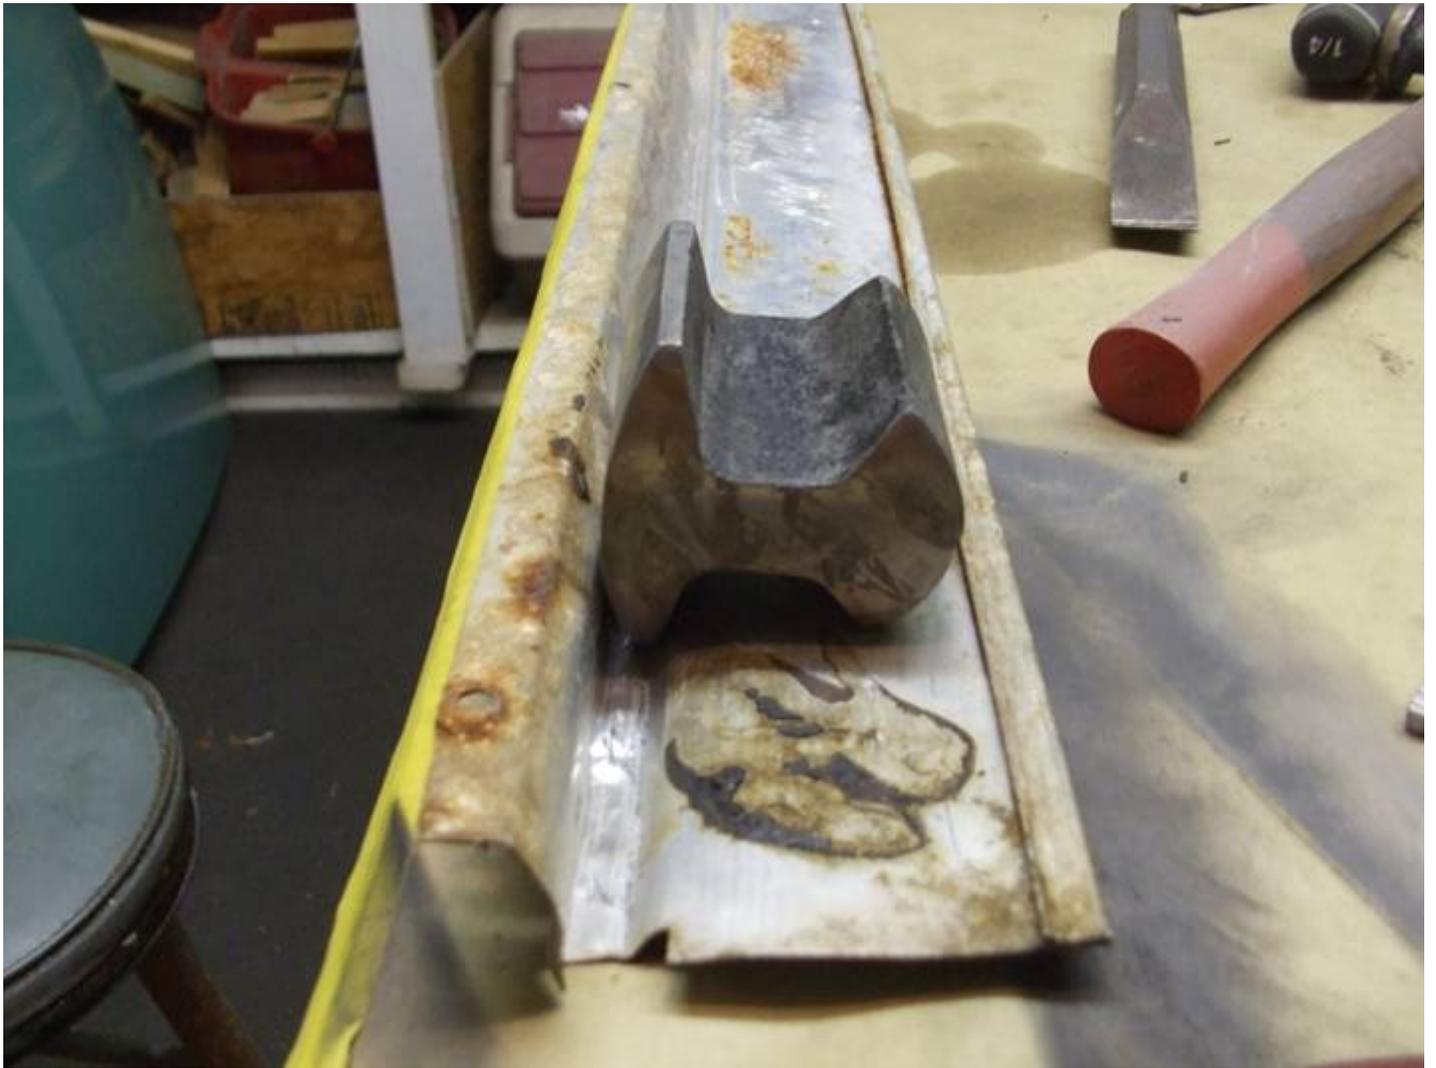
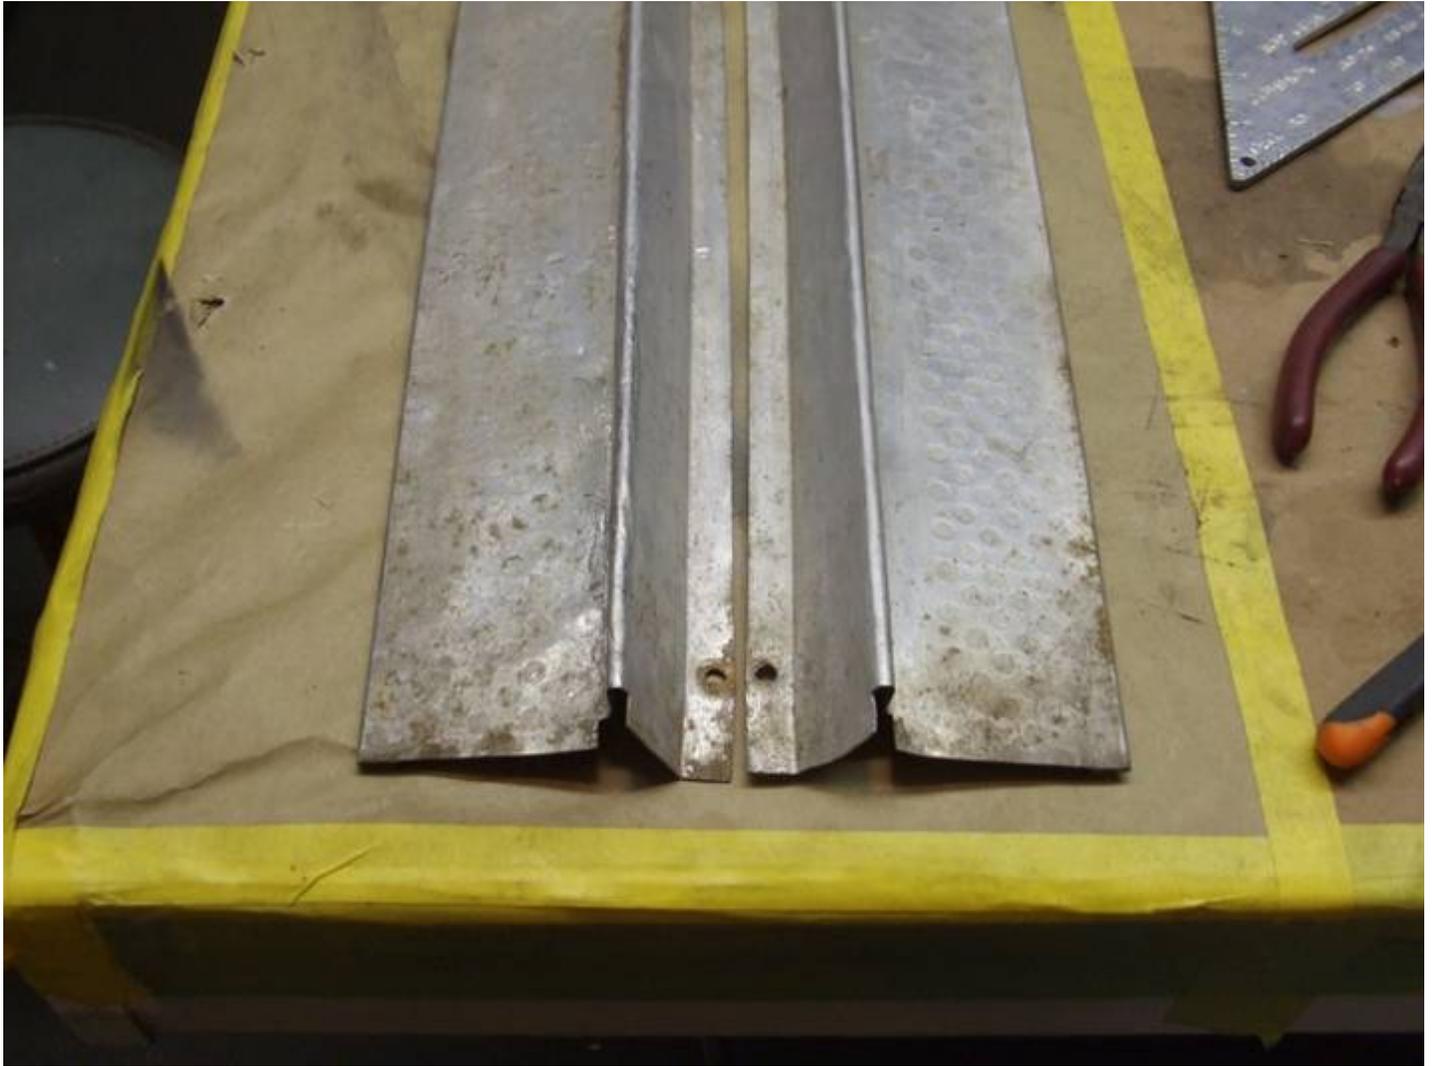
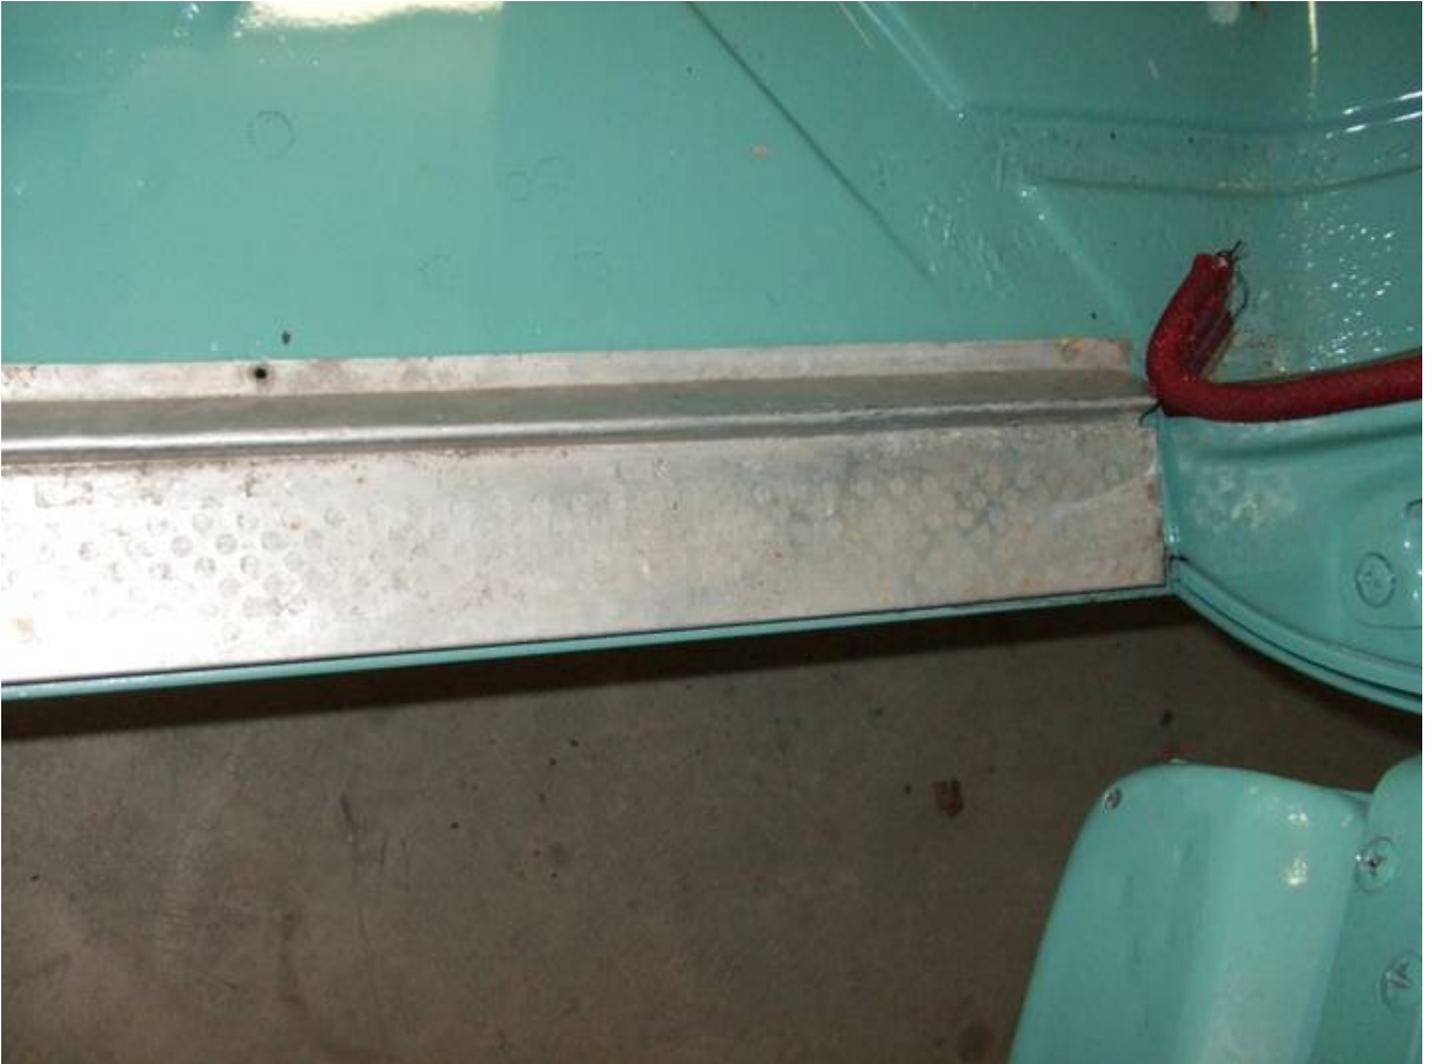
**Sill Plates:**

One of the sill plates was bent up pretty badly. Some angle iron, hammer and dolly got it straightened out pretty good.

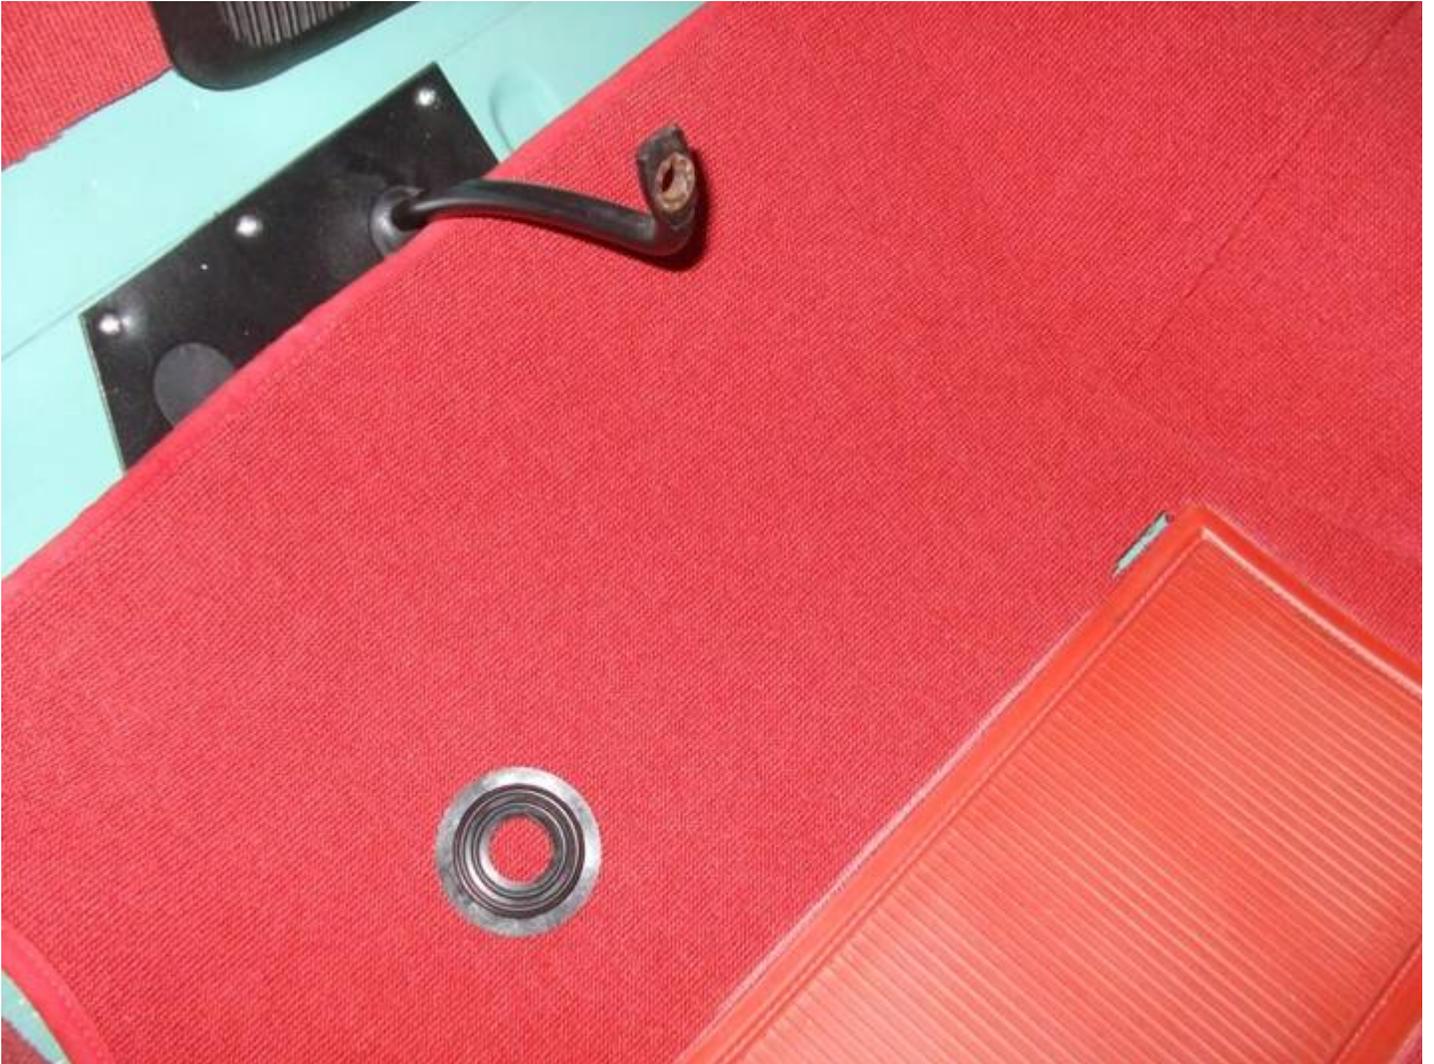
**Carpet Installation:**

I bought the carpet from Rene Harger of Southeast Studebaker, LLC. I had messed up a little while installing their headliner and had to have less mistakes with their carpet. I had to cut holes for the brake pedal, dimmer switch, and the accelerator rod boot. The only reference point on the carpet was the slit for the bottom of the accelerator pedal.

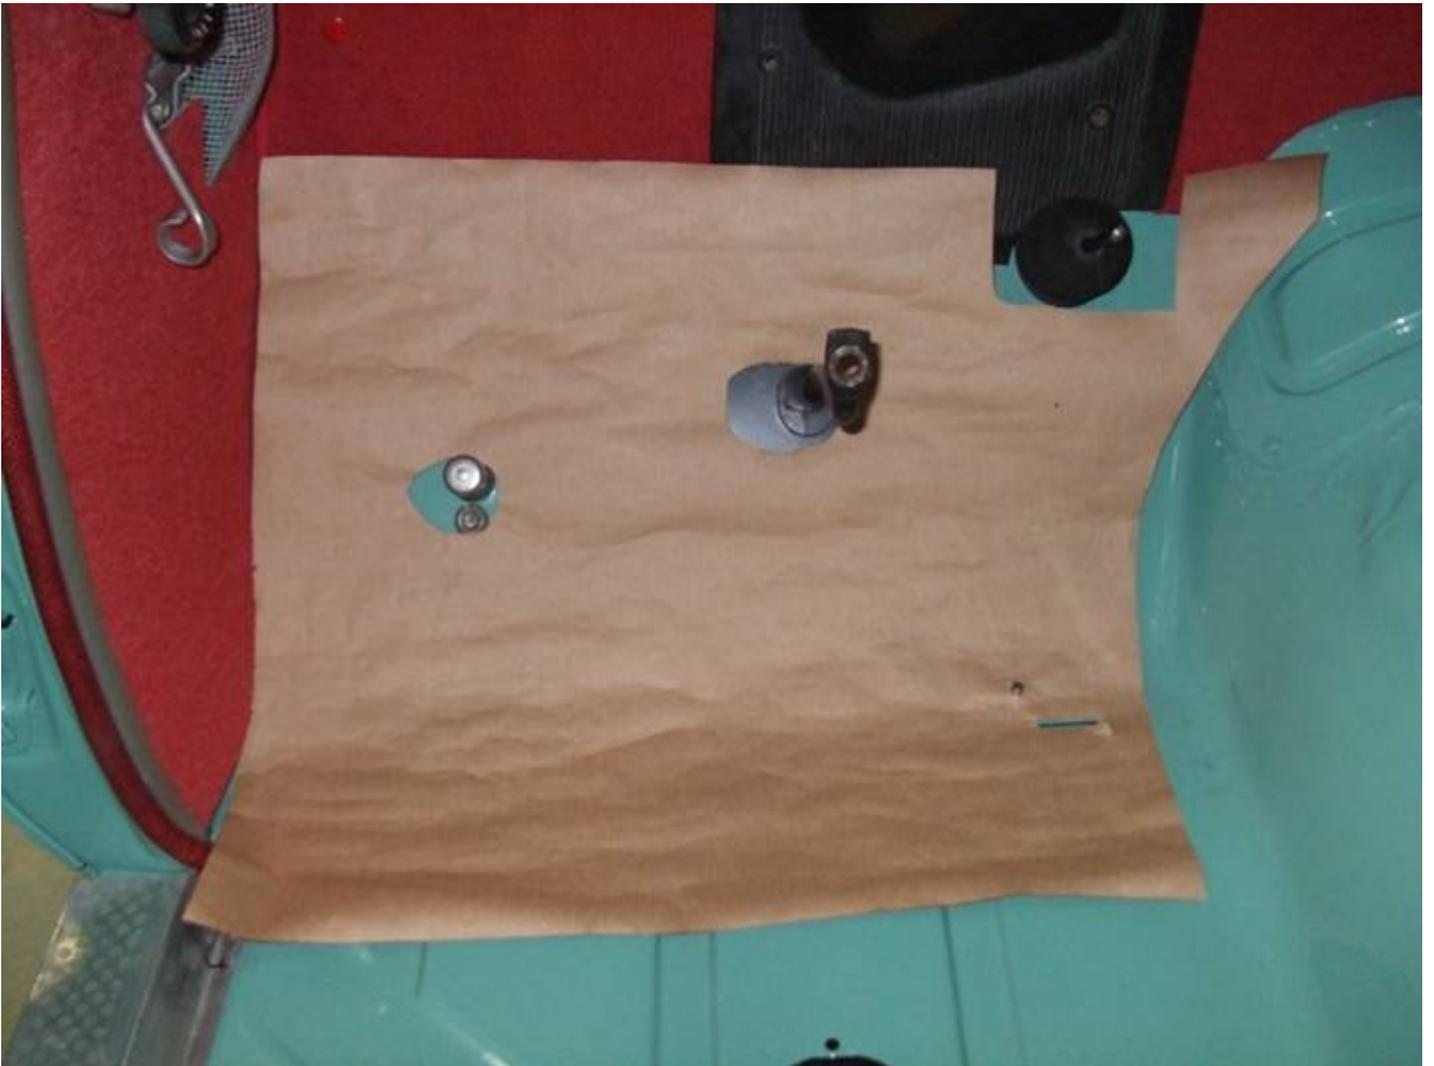
I decided to use some Kraft paper as a template. It was laid out on the upper left corner of the carpet and the slit was cut in it. I then laid the template in the floorboard lining up the slit with the base of the accelerator pedal. Large openings were cut in the template to clear the three items.

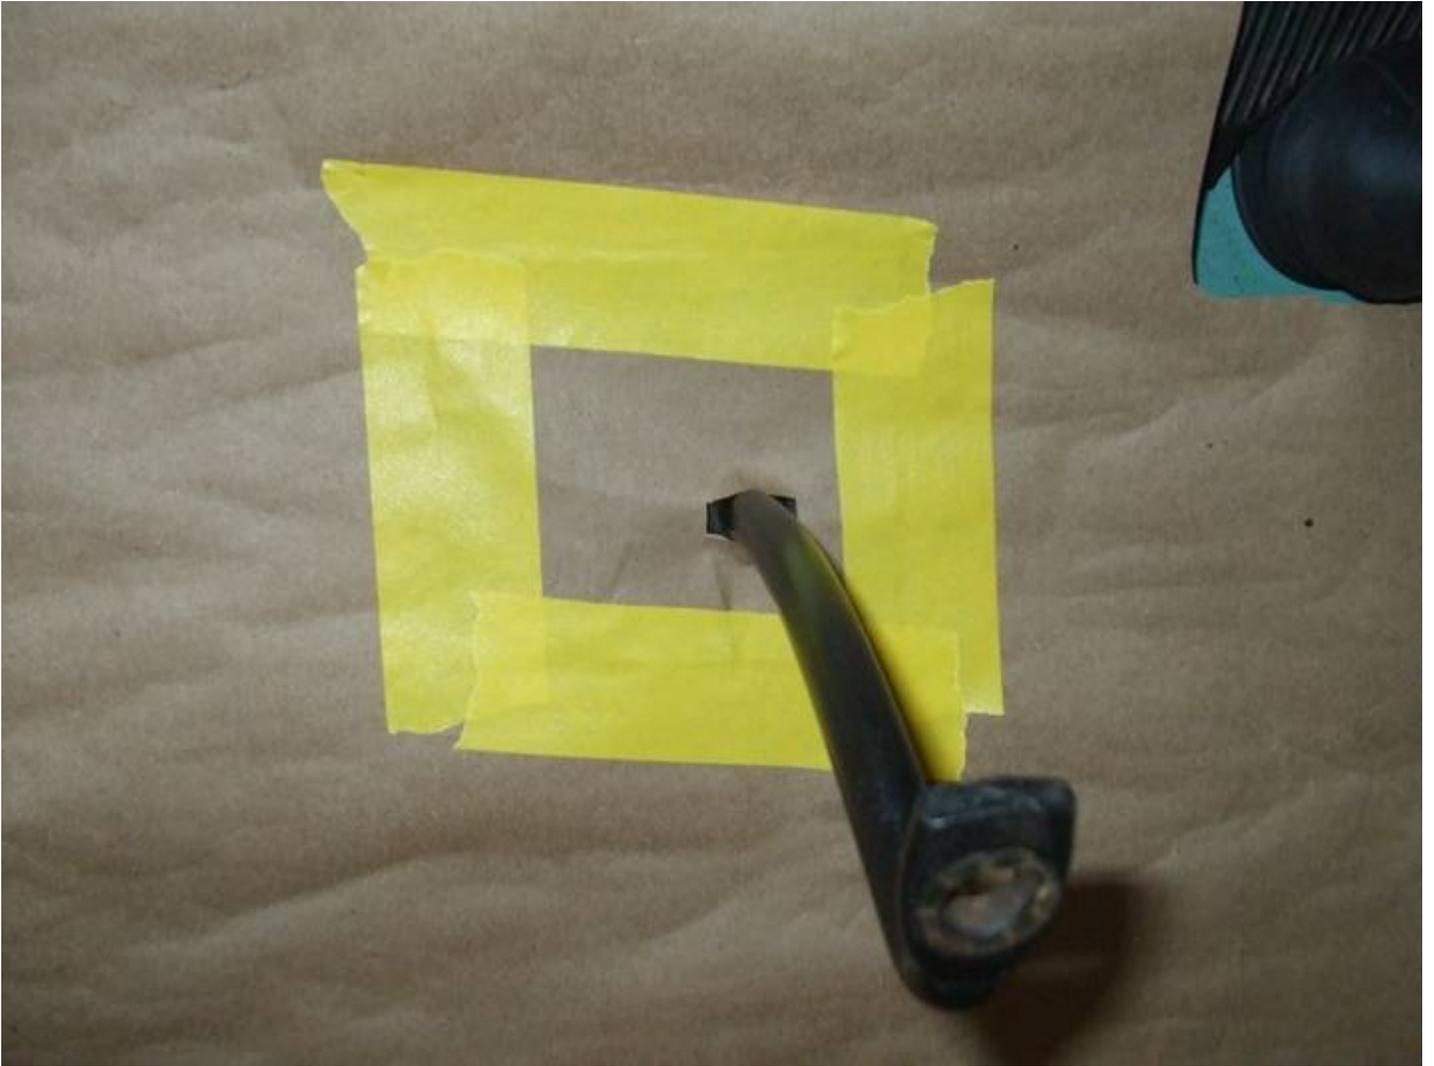
A cut to allow the brake pedal rod to go the through the carpet was cut in a smaller piece of paper. It was then taped to the roughed out template to try to get the hole cut in the right spot.
