This update will bring you up another month to 4/3/17.

**Headliner Sail Area:**

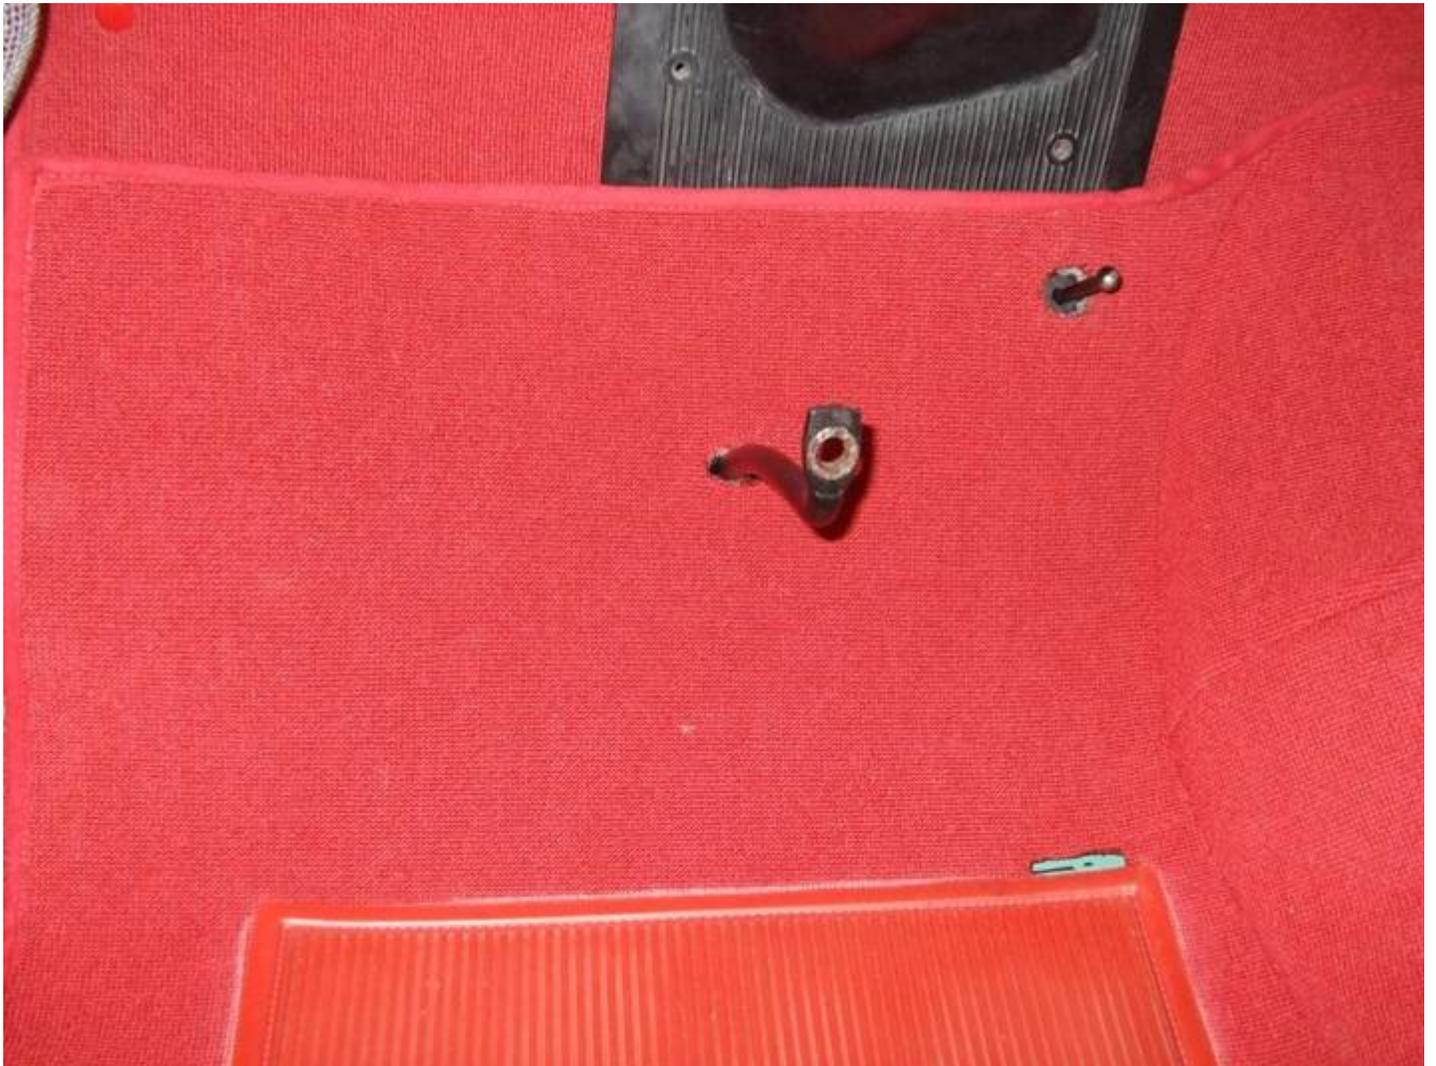
That technique worked well as at last I could get the carpet up into place and lying close to the floorboard. The dimmer switch could be felt through the carpet and its location was pretty easy to pinpoint.

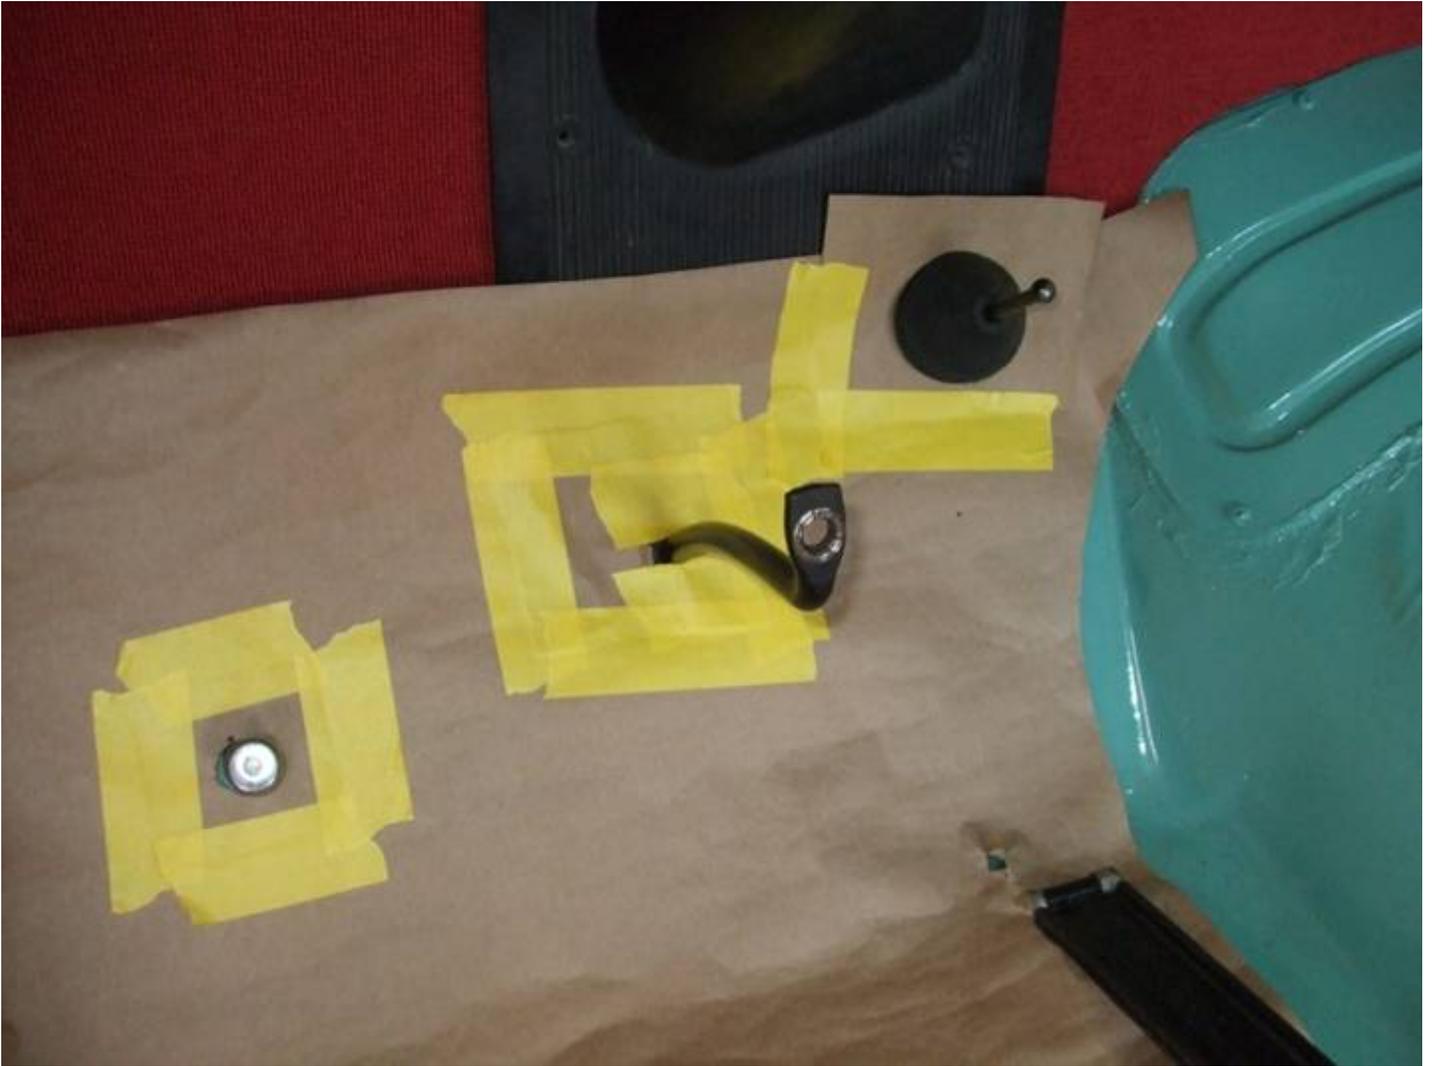
The final template was ready to use to cut the dimmer switch and boot holes.

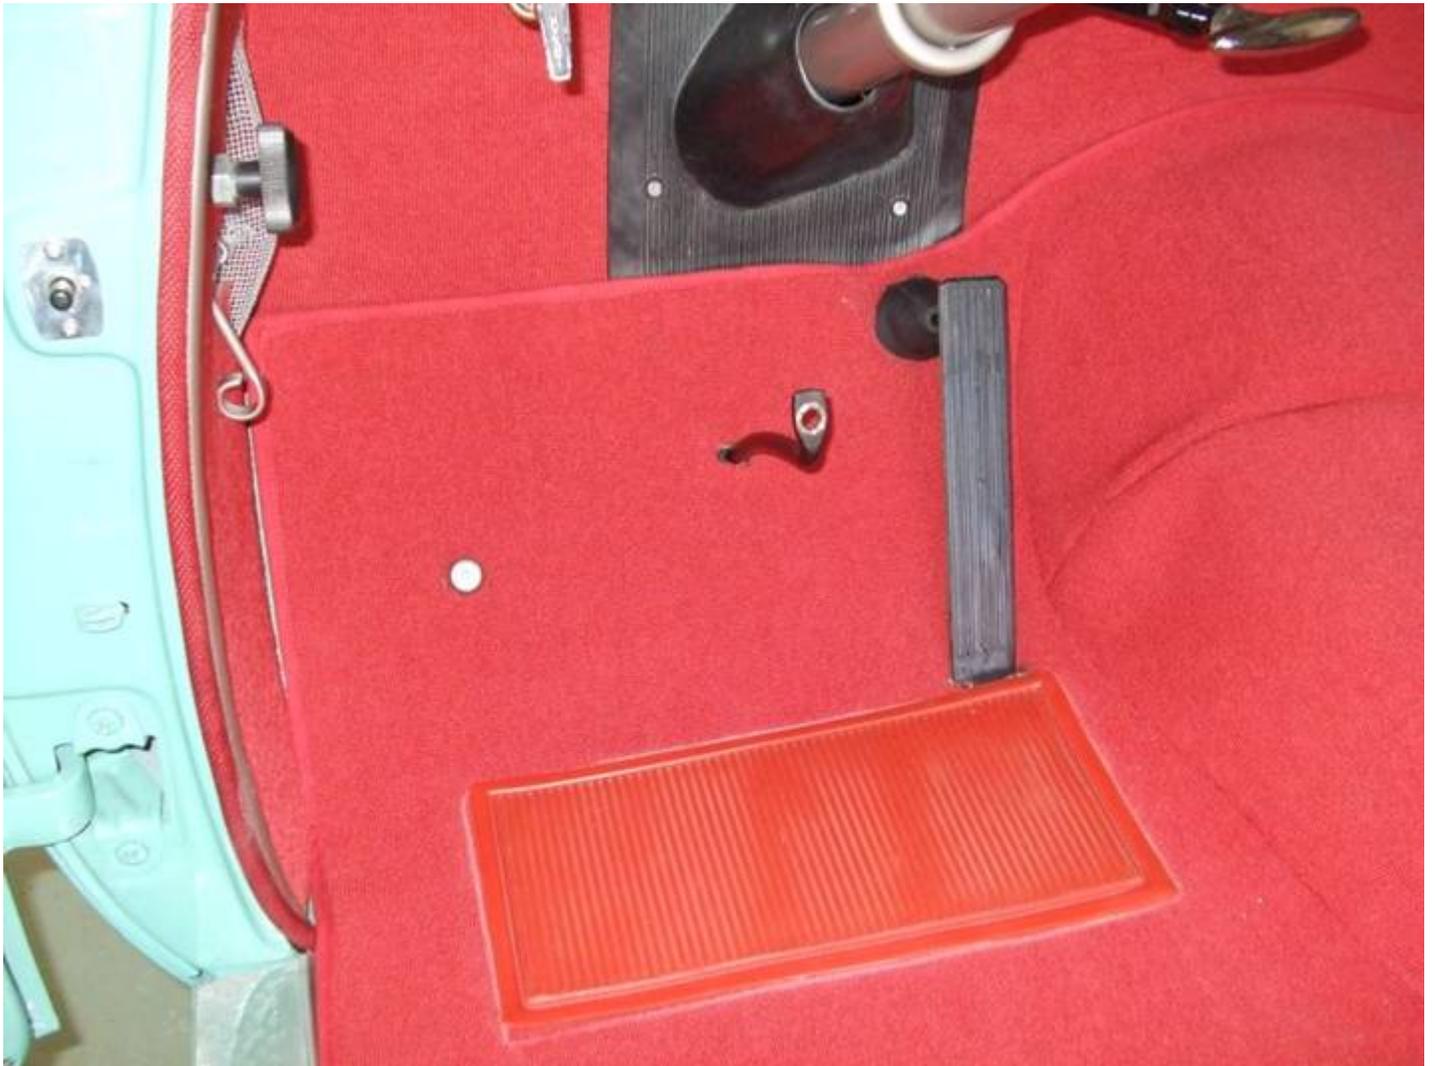
I was pretty happy with the results. The boot hole could have been  $\frac{1}{4}$ " lower but it not very noticeable. Of course I used the soldering iron to sear the carpet around the holes to keep them from fraying later.

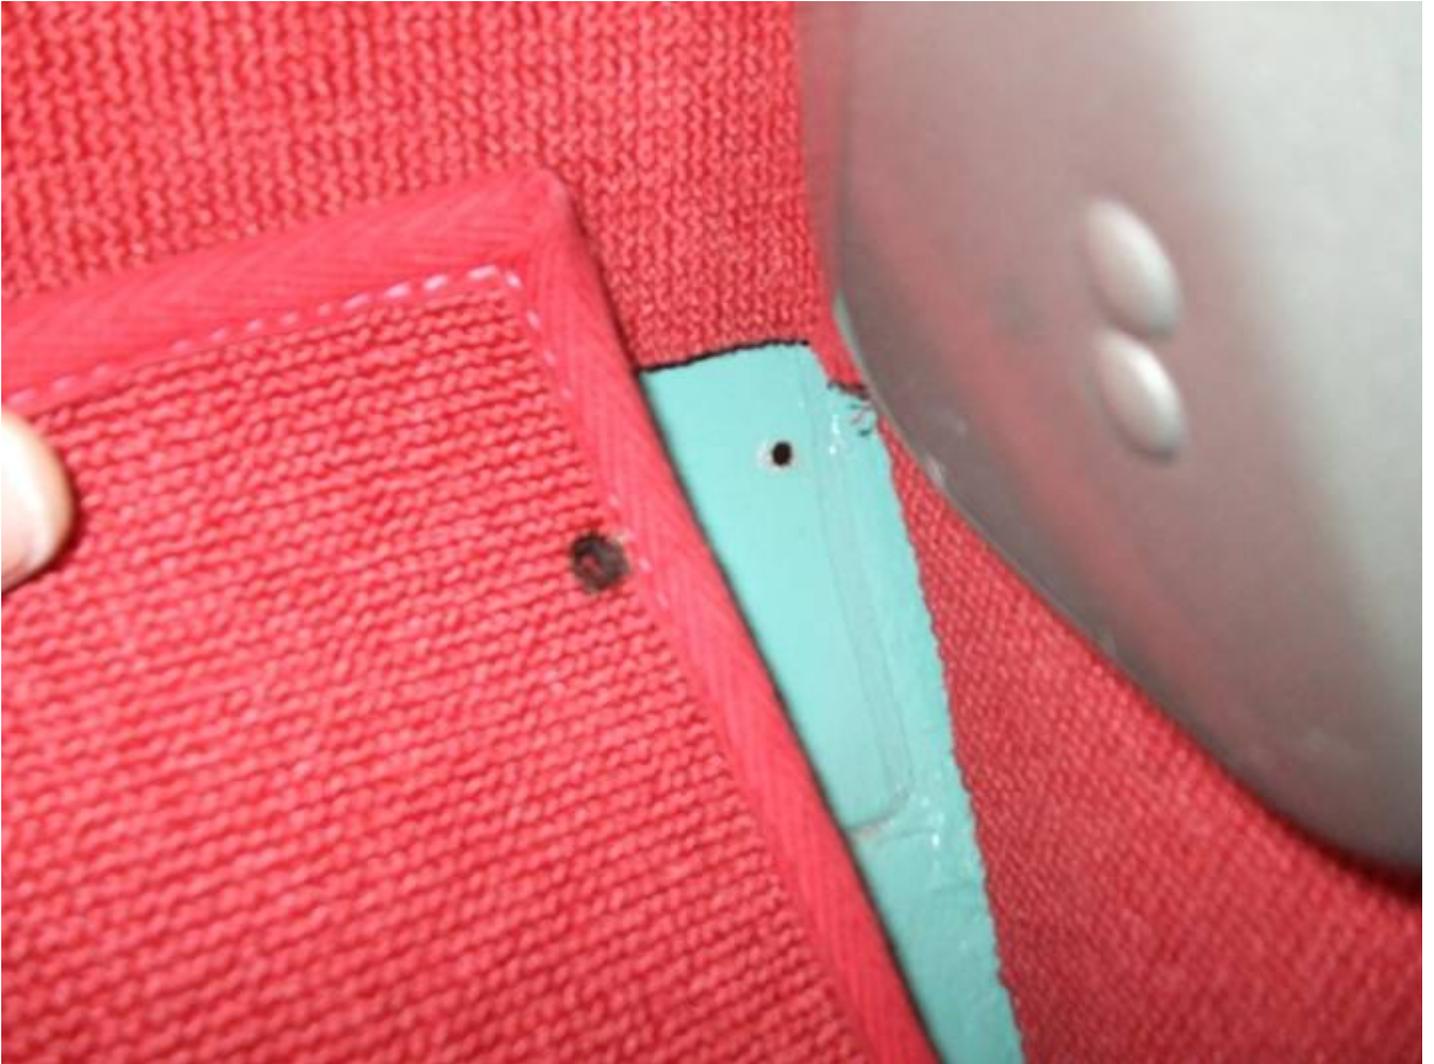
The shop manual called for screws to be placed in the upper corners of the carpet. I seared a hole through the carpet with the soldering iron and marked the place for the screw with a sharpie.

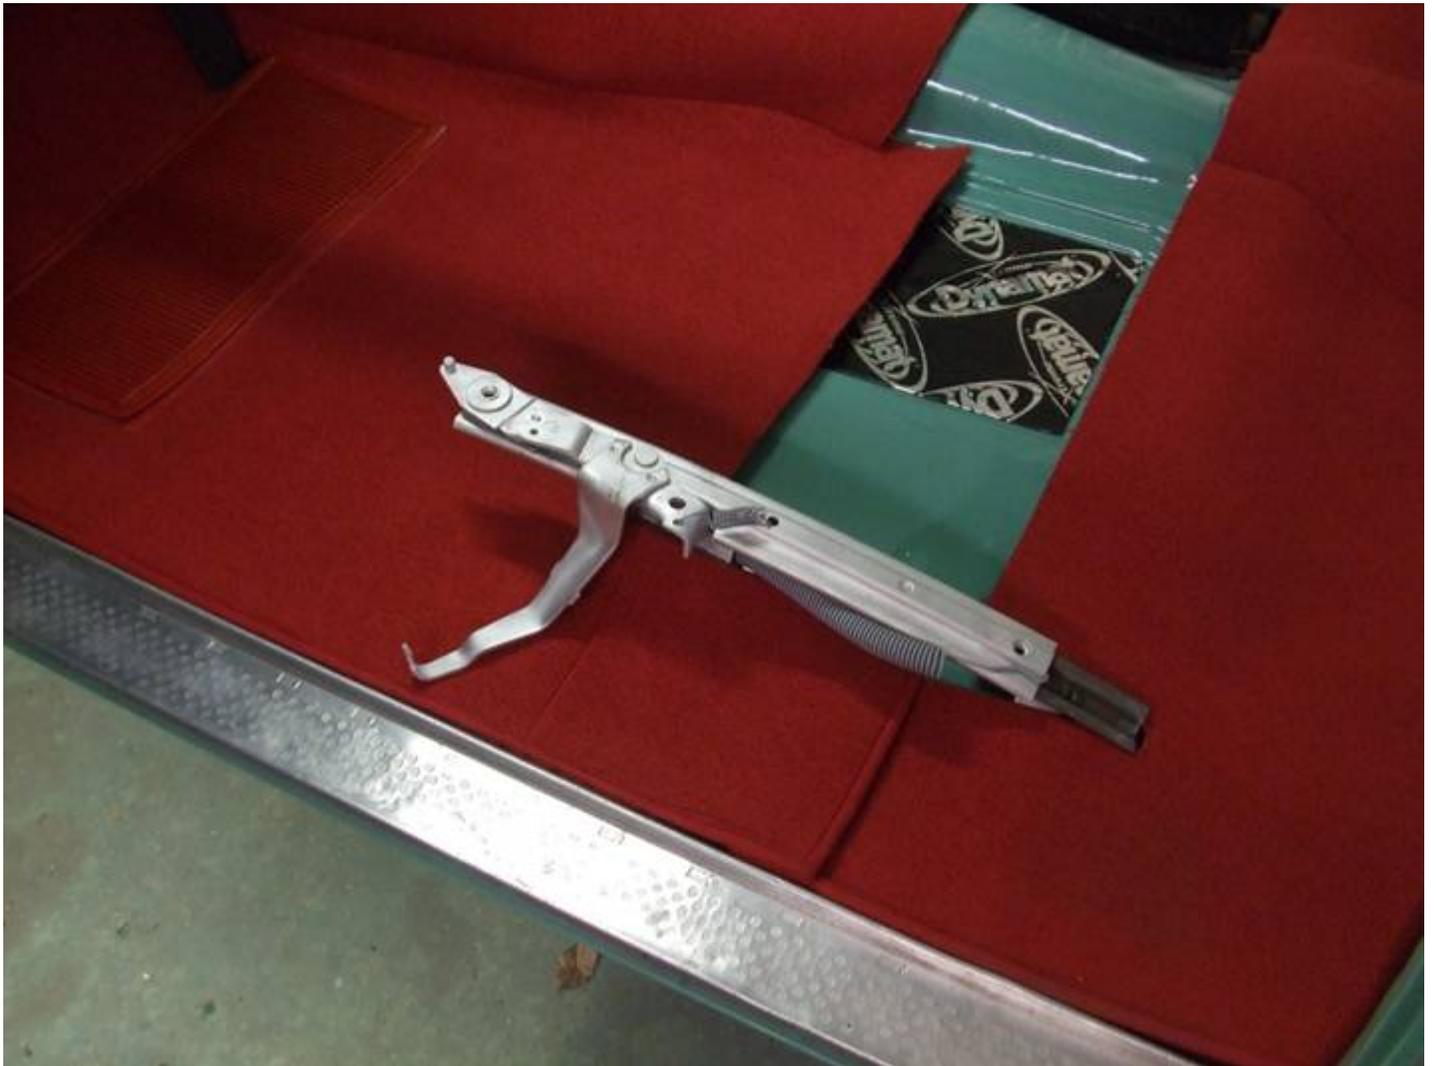
I had to use the Kraft paper again to substitute for the carpet to see how to cut out for the seat rail. Once that was done, the carpet was cut to allow it to fit around the rail nicely. The seat rail was one of the parts I had cadmium plated. It worked out nicely.

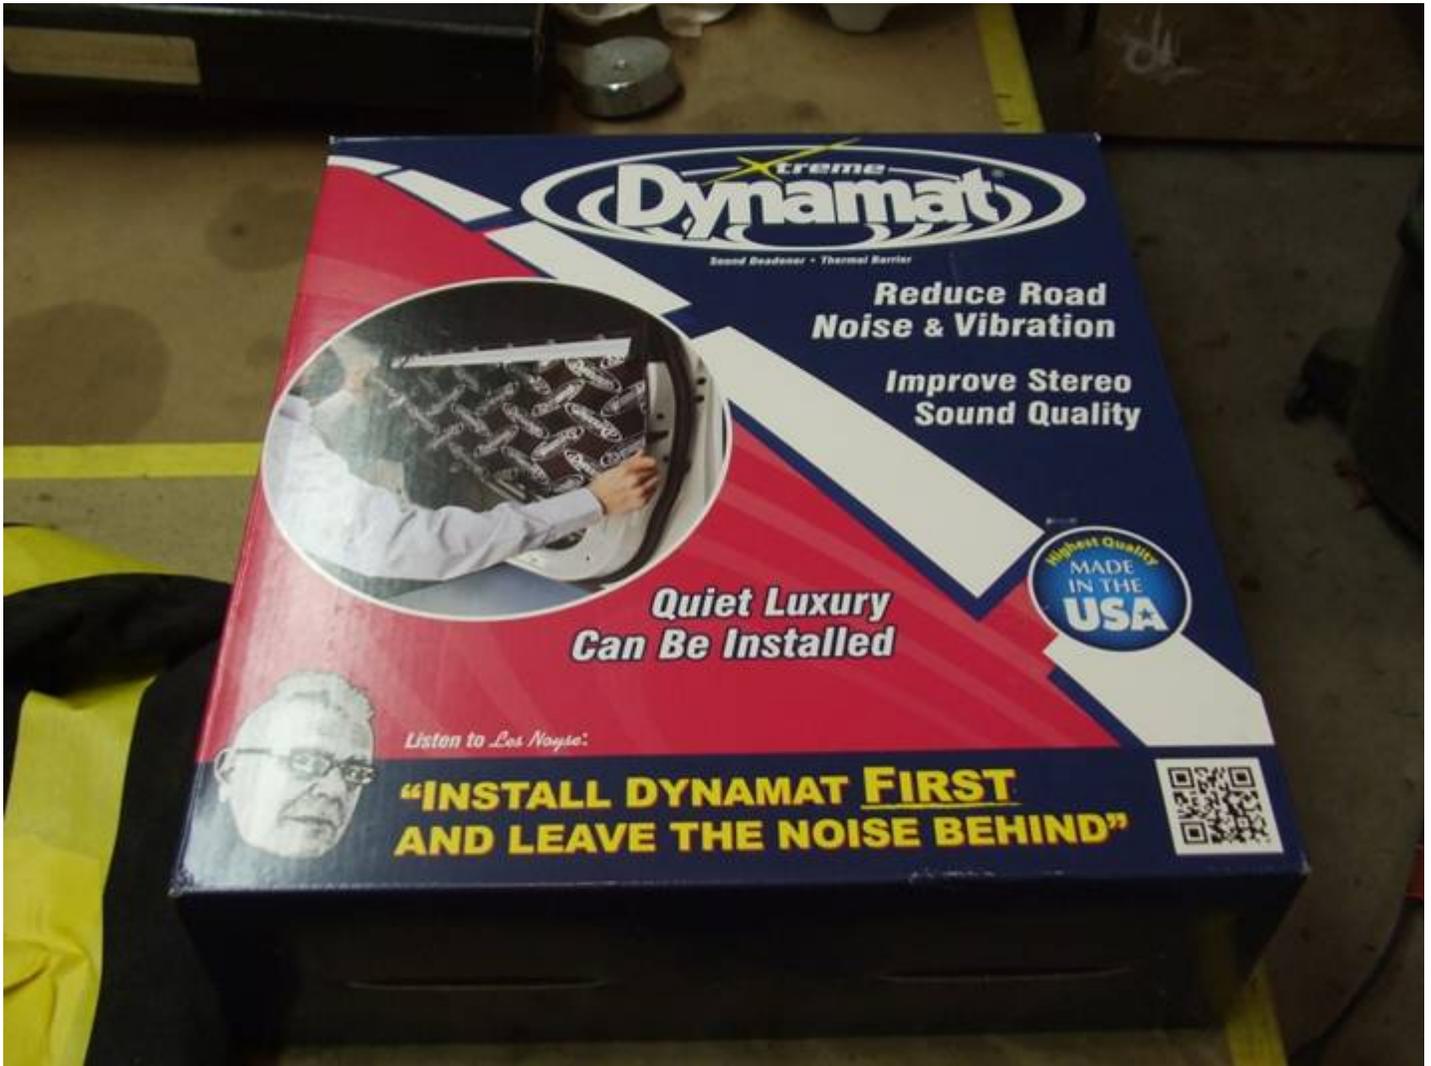
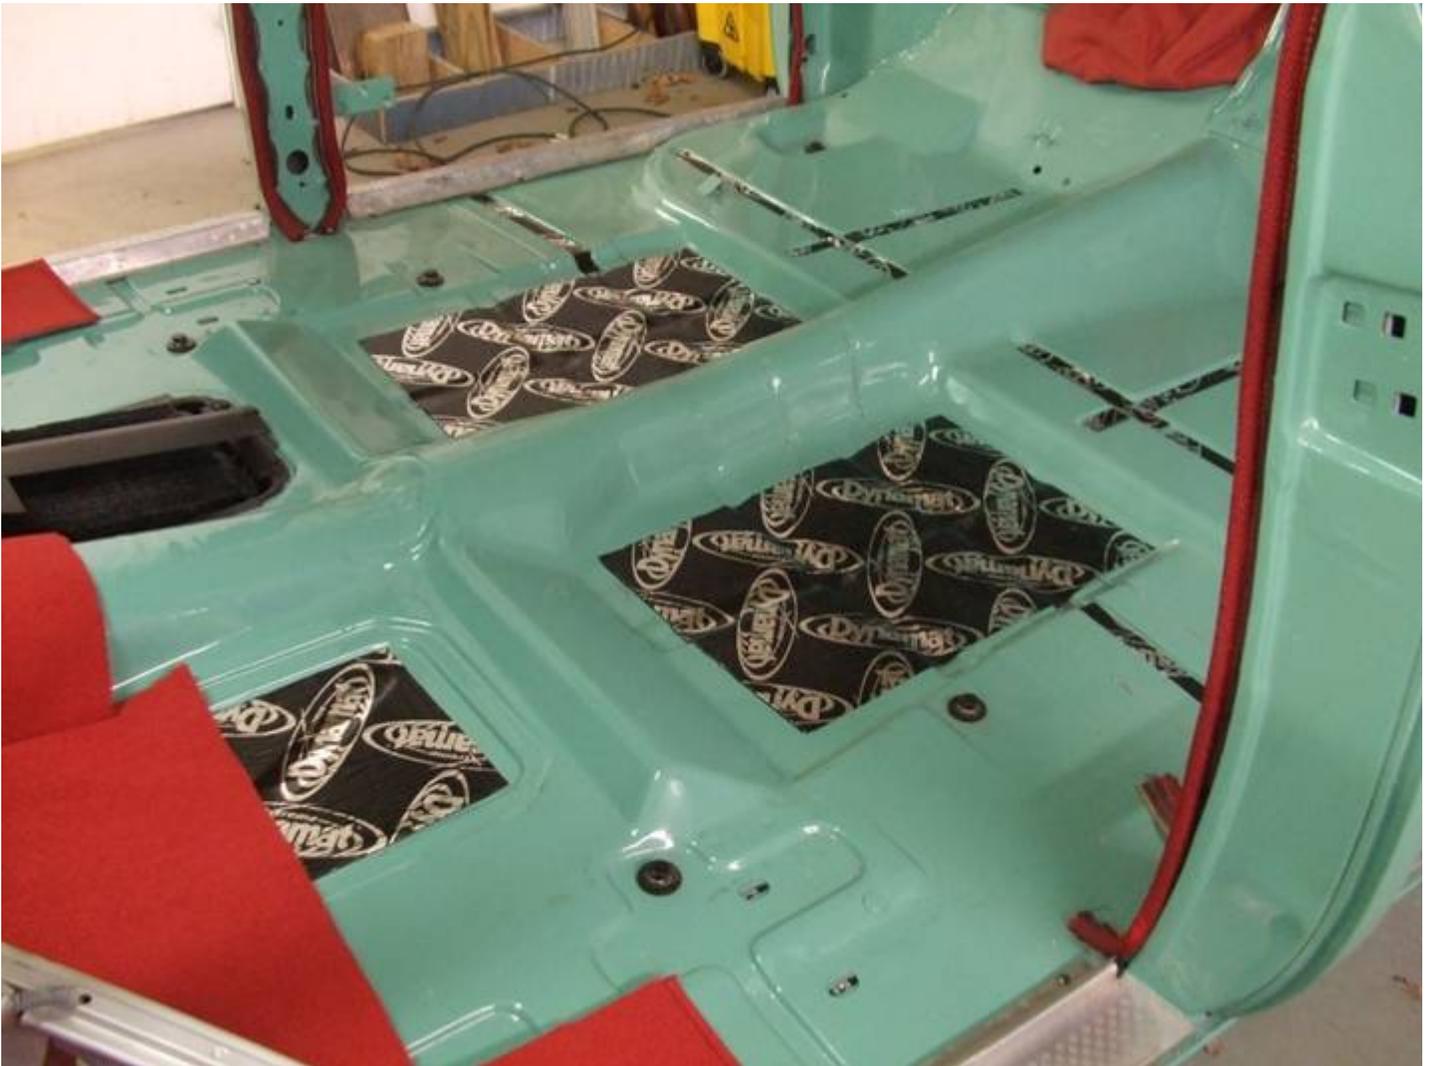
I had ordered a Dynamat door kit and decided to use part of it in the floor area of the car.

It may not make any difference at all but I thought it could not hurt. Rene had cautioned me against using any sound deadening under the carpet as it could affect the fit. I thought if I limited the sound deadening to the recessed areas of the floor it would not hurt. Of course I banged on the floor with my knuckles and at least mentally thought it sounded a little muffled.
